# 1 JBS28 (EFR C5: UPPER CALEDON)

## 1.1 SITE DESCRIPTION

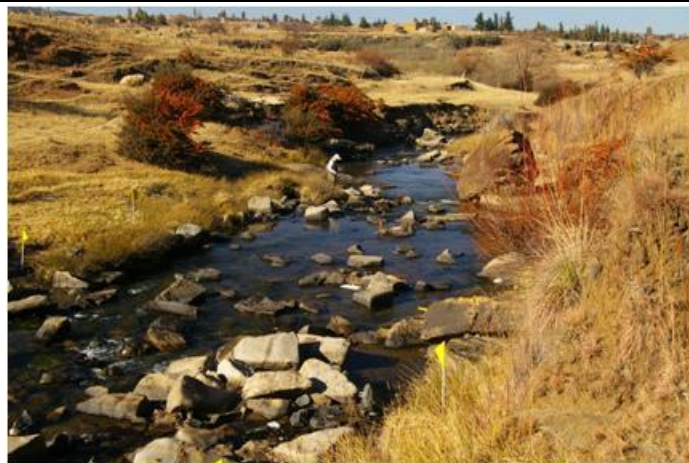
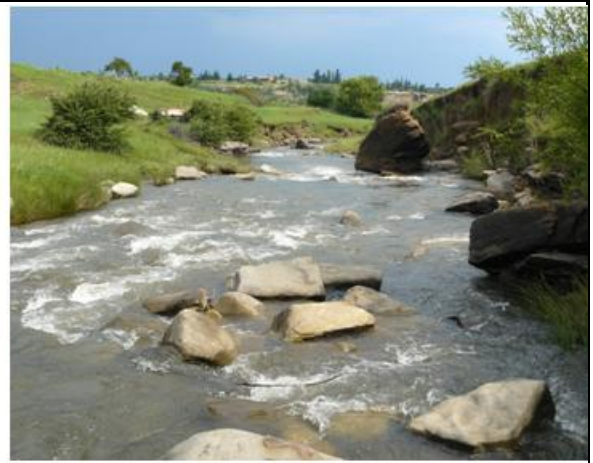
EFR C5, Caledon River. The site under different flow conditions.
