1 JBS02 (EWR 3: GLADDEDRIFT (VAAL RIVER))

1.1 SITE DESCRIPTION

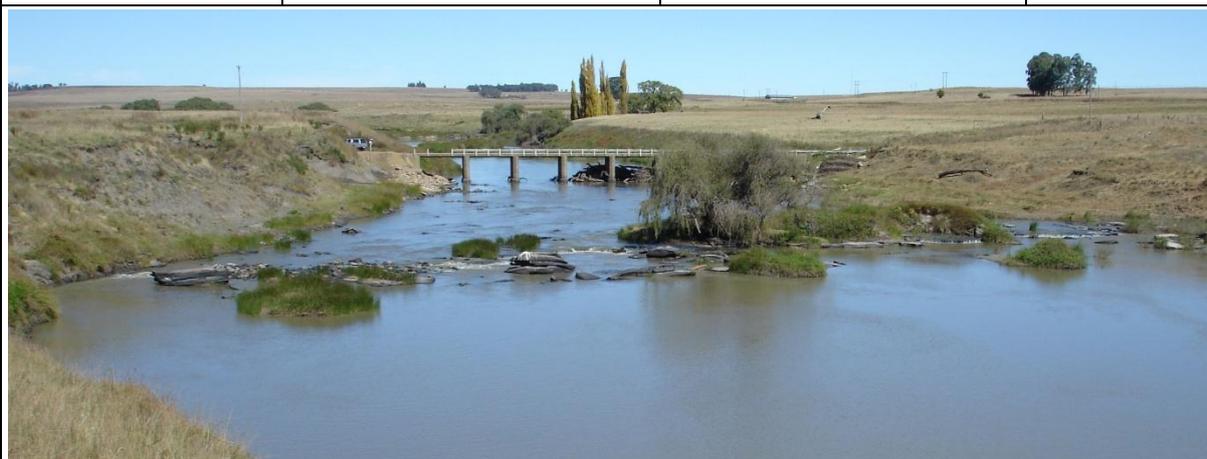
EWR 3 is situated in Management Resource Unit (MRU) Vaal C immediately below a bridge near Villiers. The site is a riffle over a dyke across the river. The morphology is not representative of the reach, but although the bedrock riffle with no terraces is well represented. The banks are cut, and erosion is present in the right bank (RB) upper zone. Some paths on the lower and upper zone have resulted in bank erosion and there is up to 20% cover by exotics. Fish habitat, flow-depth categories and cover is well represented at site, but macroinvertebrate habitat is poor.

EWR 3, Gladdedrifting, April 2008
