1 JBS03 (OSAEH 11.13: PARYS (VAAL RIVER))

1.1 SITE DESCRIPTION

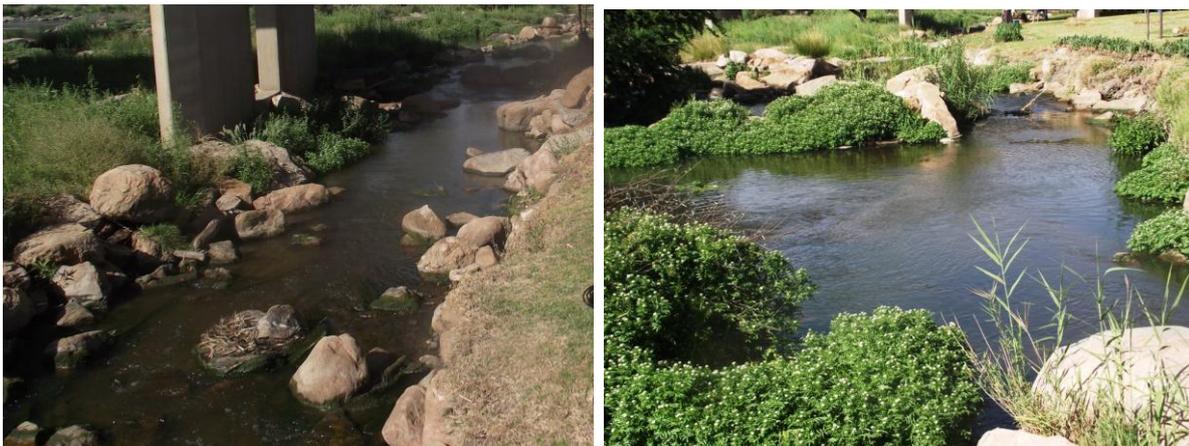
OSAEH 11.13 is situated at Parys was bedrock dominated and consisted of multiple channels. The substratum at the sampling site was slightly embedded with sediments and algae were present on some surfaces. The marginal vegetation is very well developed as a result of the available nutrients. The abundance of watercress (*Rorippa nasturtium-aquaticum*) is often an indication of excessive nutrients entering the system. The macro channel is >100 m wide at the site. The site has a diversity of instream habitats available for macroinvertebrate colonization, although filamentous algae are present on the cobbles, restricting colonization by macroinvertebrates.

Figure 1.1 Instream habitat

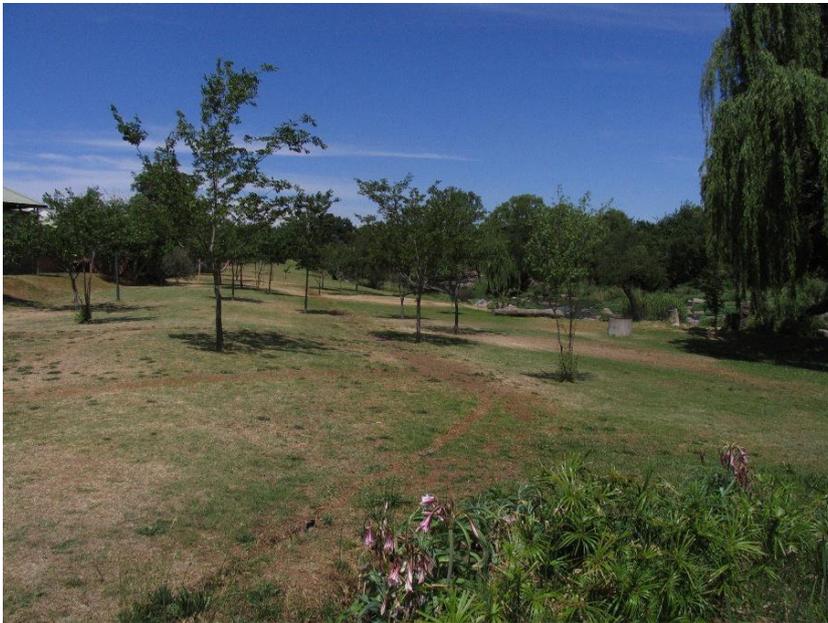
Two sites were surveyed on the right hand bank (RB) and on the left hand bank (LB). For the assessment description the RHB site was used because it was assumed that it represented more of the natural riparian areas within the greater area. Most of the other riparian zones are totally transformed into recreational areas (picnic sites, caravan parks, housing developments, etc.). The level 3 VEGRAI was used for the assessment.

Figure 1.2 Visual of LB of site indicating recreation grounds infringing into the riparian zone
