1 JBS04 (EWR 5: SCANDINAVIA (VAAL RIVER))

1.1 SITE DESCRIPTION

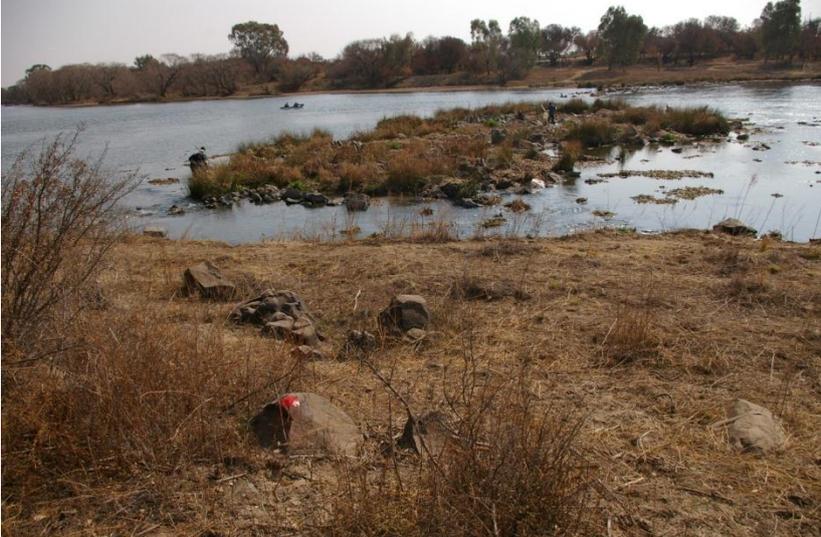
MRU Vaal E is delineated from the Vaal Barrage to the end of the Water Management Area (WMA). The site is 10 km upstream of the Mooi River confluence and the lowest EWR site situated in the Vaal River. The cross-section runs across a bedrock/boulder riffle area, but the reach characterised by generally long pools. Well developed alluvial terraces are present with minor landscaping and boulder piling. There is a high incidence of exotic species in some places with some landscaping occurring on the RB. Fish habitat, flow-depth categories and cover is well represented at site although fast habitats were limited and was supplemented by sampling another site. Macroinvertebrate habitat is moderate.

EWR 5, Scandinavia, August 2007
