# 1 JBS05 (EWR 6: KLIP (KLIP RIVER))

## 1.1 SITE DESCRIPTION

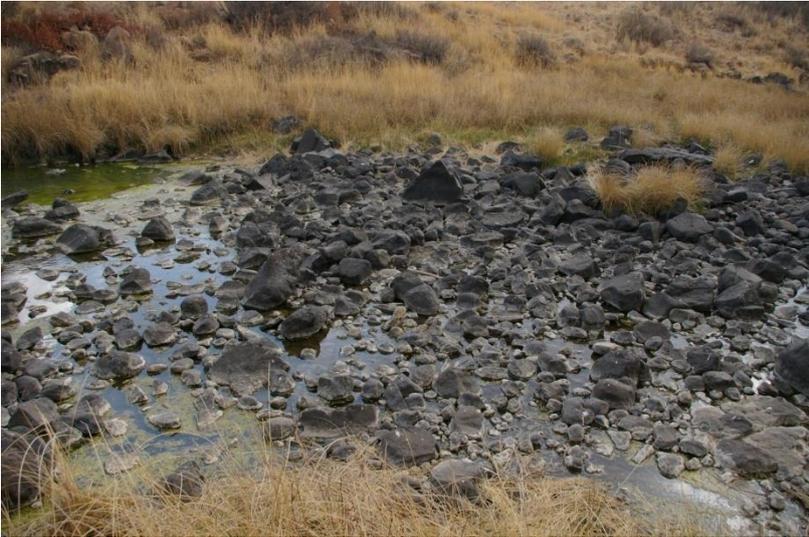
EWR 6, Klip, September 2007

EWR 6 is in MRU Klip C which extends from the Lower Foothill geomorphic zone to Lowland zone. The cross-section runs across a bedrock/boulder riffle area, and there are numerous such areas in the reach. The bed is alluvial (cobble- dominated). The left bank (LB) is bedrock, so no paired terraces occur. There is less than 20% undercutting, and stabilized by vegetation. An unnatural canal on upper zone is present and there is up to 40% cover by exotics. Fish habitat, flow-depth categories and cover is well represented at site but the presence of small weir at the site may alter natural habitat and species composition slightly. Macroinvertebrate habitat is moderate.
