1 JBS06 (EWR 7: UPPER WILGE (WILGE RIVER))

2 EWR 8: BAVARIA (WILGE RIVER)

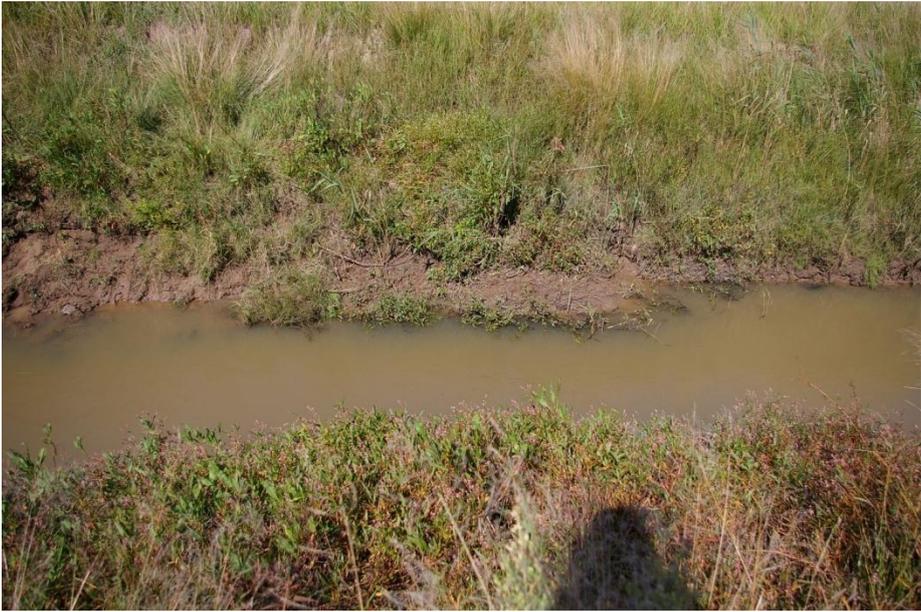
MRU Wilge A extends from the origin of Wilge River to the confluence with the Nuwejaarspruit and EWR 7 is located in this reach. The site is a meandering floodplain area within an extensive reach, and generally little impacts are present, but Braamhoek pumped storage scheme is under construction in the upper reaches - approx 17 km upstream from the site. The meandering alluvial floodplain system has good morphological cues (ox-bows etc.) Only natural undercutting and slumping was observed on cutting bends of main channel and no channel manipulation was observed at site. Fish habitat, flow-depth categories and cover is well represented at site although very limited stable flow-sensitive habitats are available, although the site is representative of this reach. Non-flow related impacts may have a negative impact on fish species (alien predatory bass) which may reduce the ability of site to sustain these species, and therefore reflect adequate flow conditions. While the channel was sufficient for sampling the floodplain was too extensive. Macroinvertebrate habitat is very poor.

EWR 7, Upper Wilge, April 2008

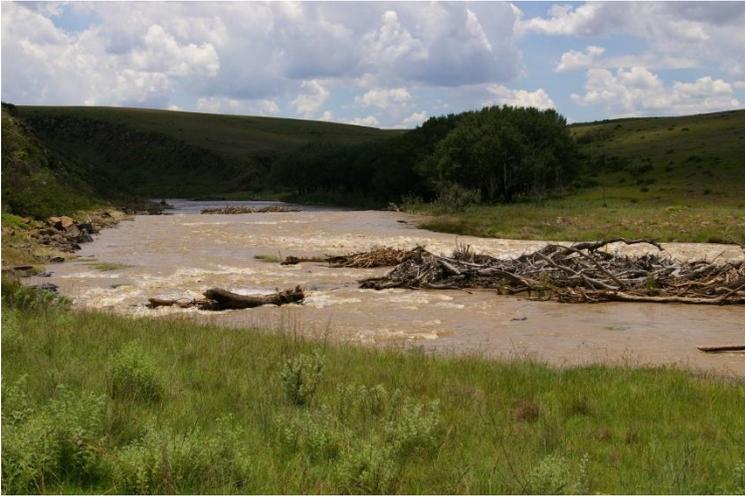
EWR 8 in the Wilge occurs in MRU Wilge B which extends from Nuwejaarspruit to the Holspruit. The site is at the beginning of a bedrock gorge and not representative of most of the reach. The bedrock nature of the channel makes the banks insensitive to flow changes, and therefore not a good area for obtaining information on the condition of the river. There are no morphological cues in this predominantly fixed boulder dominated area. There are less than 10% exotic species at the site, and poplars are aggressive invaders locally. No channel manipulation was observed at site. Fish habitat, flow-depth categories and cover is well represented at site, but macroinvertebrate habitat is poor.

EWR 8, Bavaria, December 2007
