1 JBS11 (EWR 11: BLESBOK (BLESBOKSPRUIT RIVER))

1.1 SITE DESCRIPTION

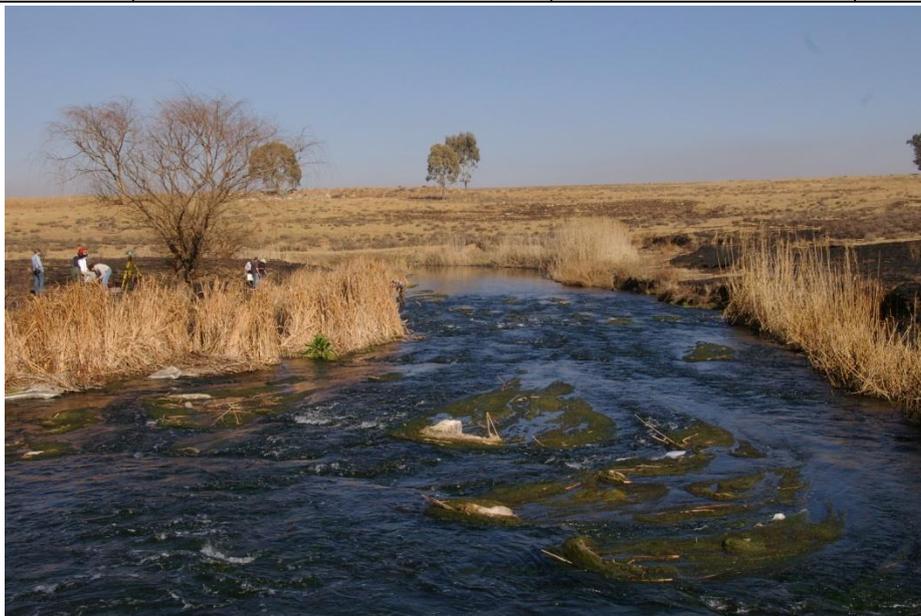
EWR 11, Blesbokspruit, August 2008

The whole Blesbokspruit River has been delineated as one MRU, MRU Bles A. The site morphology is generally representative of the reach, but impacts concentrated around the road/bridge access results in the banks being in a poorer condition than generally seen along the reach. There are approximately paired terraces on both banks and instream features are scoured out (probably due to increased flows and recent floods). Some channel manipulation from low and high-level bridges upstream was observed and there is up to 20% exotics in places. Fish habitat, flow-depth categories and cover is well represented at site. Non-flow related impacts may have negative impact on semi-rheophilic species (reduced water quality, extensive algal growth on substrate) which may reduce the ability of site to sustain these species. Macroinvertebrate habitat is poor.
