1 JBS13 (EWR 12: VERMAASDRIFT (VAAL RIVER))

1.1 SITE DESCRIPTION

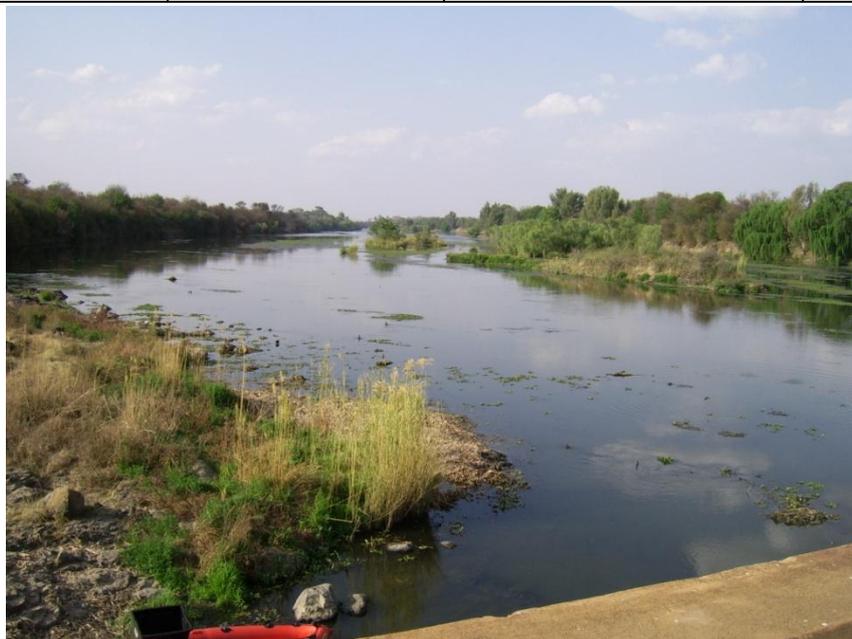
EWR 12, Vermaasdrift

EWR 12 is situated downstream of Parys and upstream of the confluence with the Koekemoerspruit at Vermaasdrift on the main stem of the Vaal River. The site is a single thread straight channel with a flat bed which is alluvial controlled. A fixed boulder floor with sand dominates the reach. Fish habitat is well represented at site as well as flow-depth categories and cover. Macroinvertebrate survey habitat availability is moderate at EWR 12 and is not a limiting factor of macroinvertebrate diversity. The site is not ideal for vegetation assessment as vegetation in the area has been disturbed by the construction of the bridge at Vermaasdrift and is not representative of the vegetation along this reach of the Vaal River.
