# 1 JBS14 (OSAEH 11.1: WOLWESPRUIT (VAAL RIVER) – OSAEH 11.5)

## 1.1 SITE DESCRIPTION

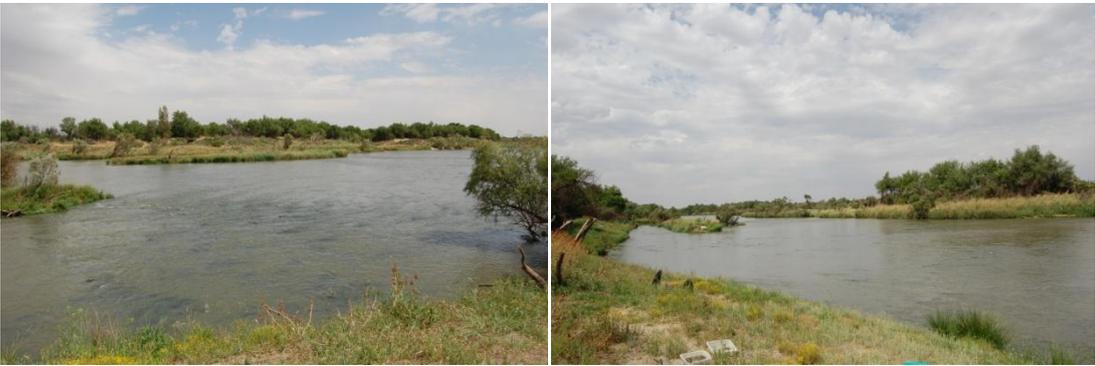
Site OSAEH 11.1 indicating extensive runs over mainly cobble substrate.

The site, at the time of sampling, was dominated by extensive instream runs, with dense algal growth occurring on the substratum. Marginal vegetation was of excellent quality and quantity, with limited stones out of current biotope present. The substratum was mostly cobbles, gravel and sand, with some boulders present.
