1 JBS15 (OSAEH 11.6: RHENOSTERSPRUIT)

1.1 SITE DESCRIPTION

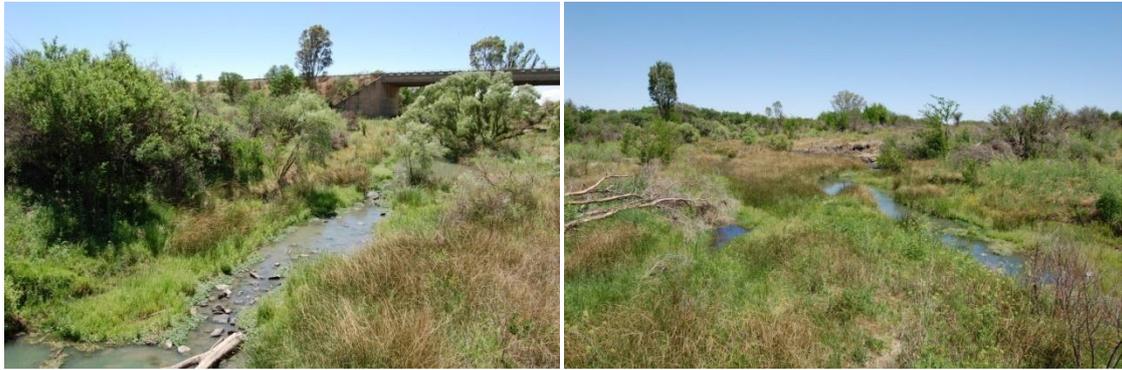
Site OSAEH 11.6 indicating excellent marginal vegetation but poor stream flow

At the time of sampling, little to no flow was present at the site. The site consists of pool sections, as well as cobble and sand sections with very little flow. Marginal vegetation was of excellent quality and quantity. The substratum was mostly cobbles, sand and mud, with good SOOC biotope present. Algae were also present on the cobbles.
