1 JBS17 (EWR 14: PROKLAMEERSDRIFT (VALS RIVER))

1.1 SITE DESCRIPTION

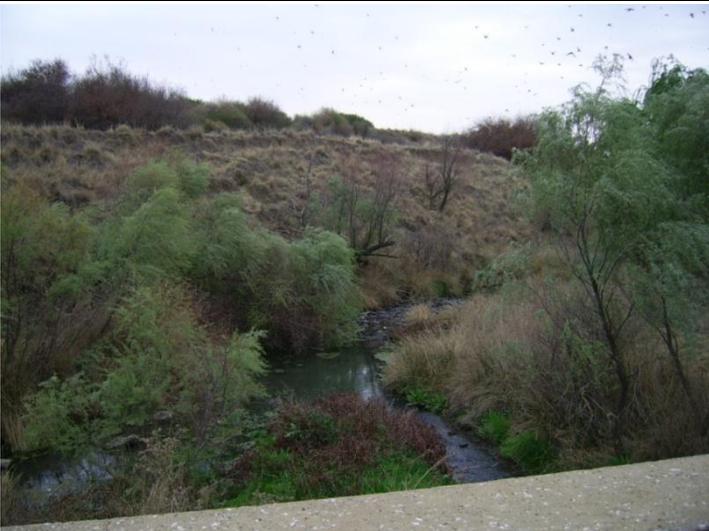
EWR 14, narrow main channel with cobble dominated riffle.

The site consists of a relatively narrow area of flow with moderately sloping banks. Fish habitat is well represented at site as well as flow-depth categories and cover. Macroinvertebrate survey habitat availability is adequate and is not a limiting factor of macroinvertebrate diversity. Riparian vegetation at the site is representative of the area.
