VEGETATION SPECIALIST STUDY

With reference to potential dam sites in the Vioolsdrif and Komsberg areas

Lower Orange River Management Study

November 2003

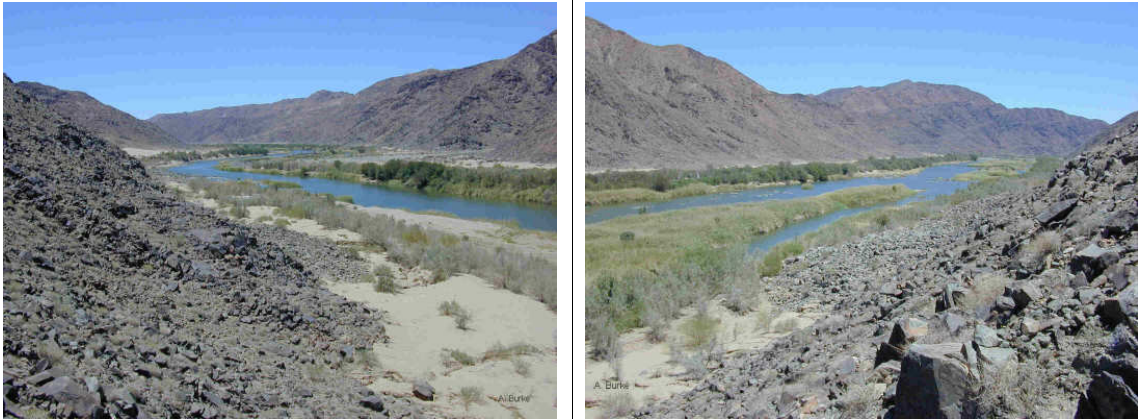
Vioolsdrif A

Position	28°45.34' S and 17°48.86' E
Access route	Existing track on south-bank to weir (28°45.78' S and 17°43.80' E), difficult from there upstream; north-bank: existing track for about 4 km from west, then very steep slopes reaching to the river banks – very difficult and major road construction would be required. The road construction impacts would be larger than the impacts of dam construction.
Affected riparian vegetation	<i>Prosopis</i> sp. – <i>Tamarix usneoides</i> woodland on drybank (northbank), <i>Acacia karoo</i> woodland on south-bank, <i>Phragmites australis</i> reed beds
Affected adjacent vegetation	Directly affected by inundation: <i>Sisymbrium sparteum</i> – <i>Zygophyllum microcarpum</i> shrubland on sand plain and footslopes, <i>Zygophyllum cf album</i> dwarf shrubland on mountain slopes
Topography	Narrow river valley
Habitats	Mountain slopes, river banks (dry- and wetbank), boulder areas, islands, backwaters

Existing disturbance	<ul style="list-style-type: none"> ▪ <i>Prosopis</i> species invading ▪ some burned patches on north-and south-bank
Alien vegetation	<i>Prosopis</i> species (<i>P. glandulosa</i> and <i>P. velutina</i>), <i>Ricinus communis</i>
Other...	<ul style="list-style-type: none"> ▪ A weir downstream of site A has to some extent stabilised flow conditions for approximately 5 km length of this stretch of river. As a result riparian habitat diversity along this stretch is reduced and no boulder areas, backwaters, sand banks or islands were present at the time of the survey (low flow conditions). ▪ The south-bank west of the potential dam site A is invaded by <i>Prosopis</i> species.
Recommendation	<ul style="list-style-type: none"> ▪ If a dam site is considered in this area, it should be moved as far west as possible towards Vioolsdrif to inundate, as far as possible, already disturbed areas and alien vegetation, rather than less disturbed stretches of river further upstream.

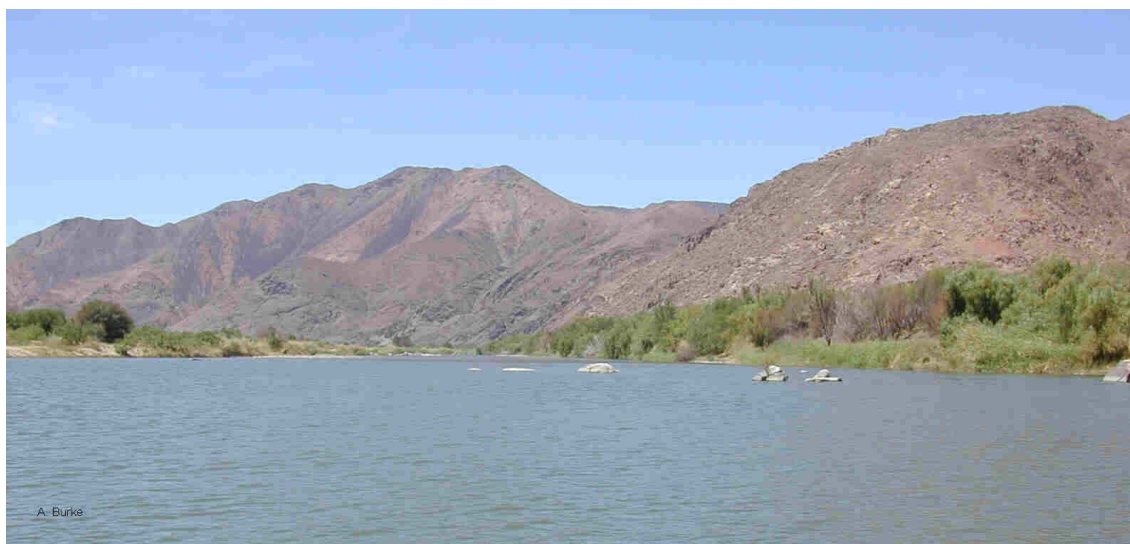
Violsdrif B

view upstream

Position	28°46.45' S and 17°55.62' E
Access route	Existing track via Haib River in Namibia, could be upgraded without major impacts.
Affected riparian vegetation	<i>Prosopis</i> species - <i>Tamarisk usneoides</i> woodland on drybank, <i>Phragmites australis</i> on wetbank, localised patches of <i>Rhus pendulina</i> and <i>Acacia karoo</i> woodland on south-bank. <i>Gomphostigma virgatum</i> on boulders in riverbed.
Affected adjacent vegetation	Directly affected by inundation: <i>Sisyndite spartea</i> shrubland on sand plain and <i>Zygophyllum cf album</i> dwarf shrubland on mountain slopes
Topography	Narrow river valley with wider section of sand deposit on north-bank
Habitats	Mountain slopes, river banks, boulder areas, islands, backwaters
Existing disturbance	<ul style="list-style-type: none"> ▪ burned sections ▪ patches with <i>Prosopis</i> species invading, particularly in burned areas
Alien vegetation	<i>Nicotiana glauca</i> , <i>Prosopis</i> species (<i>P. glandulosa</i> and <i>P. velutina</i>), <i>Ricinus communis</i>

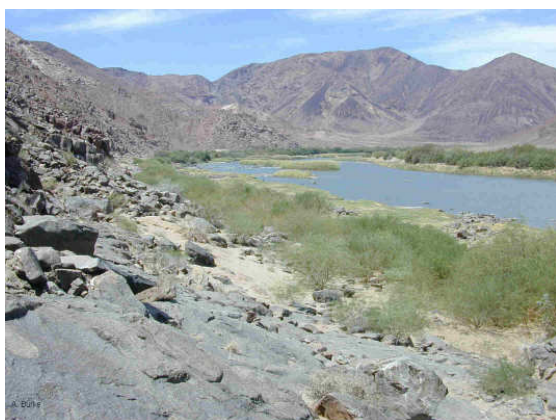
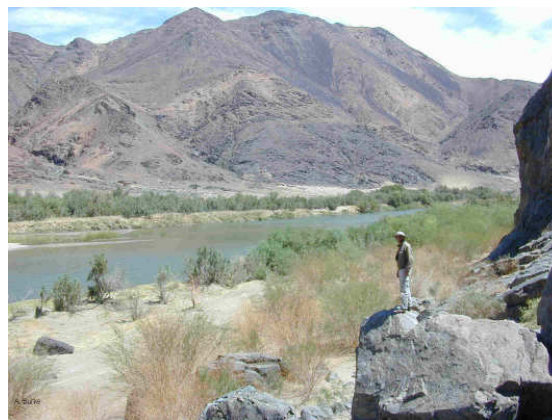
Violsdrif C

view upstream

view downstream

Position	28° 47.37' S and 17° 56.89' E
Access route	Existing track via Haib River in Namibia to site B, from there narrow river valley and road build-up would be required, resulting in substantial construction impacts.
Affected riparian vegetation	<i>Prosopis</i> woodland on drybank (N), <i>Rhus pendulina</i> – <i>Salix mucronata</i> woodland on south-bank, <i>Gomphostigma virgatum</i> on boulders in riverbed, sections with <i>Ziziphus mucronata</i> on south-bank, <i>Phragmites australis</i> reed beds.
Affected adjacent vegetation	Directly affected by inundation: <i>Sisymbrium sparteum</i> shrubland on sand plain and footslopes and <i>Zygophyllum cf album</i> dwarf shrubland on mountain slopes
Topography	Narrow river valley
Habitats	Mountain slopes, river banks, boulder areas, islands
Existing disturbance	<ul style="list-style-type: none"> ▪ burned sections ▪ patches with <i>Prosopis</i> species invading, particularly in burned areas and in wetbank

Alien vegetation	<i>Prosopis</i> species (<i>P. glandulosa</i> and <i>P. velutina</i>), <i>Ricinus communis</i>

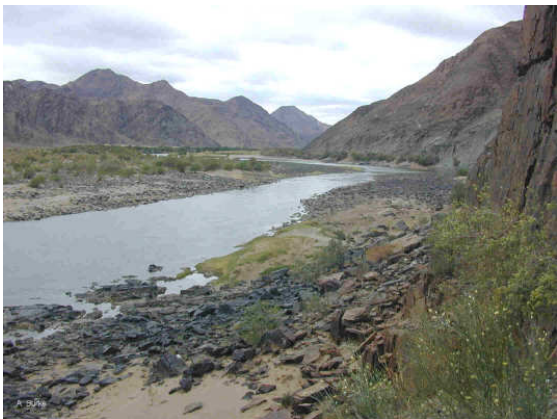
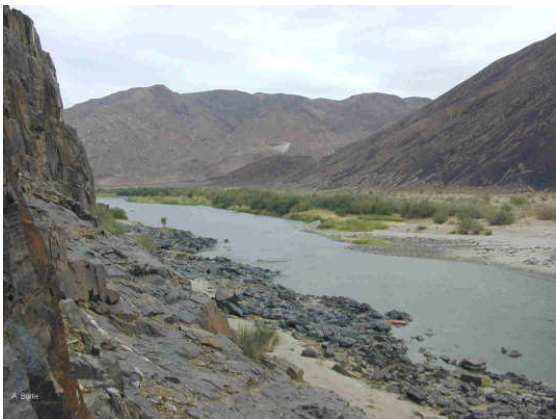
Violsdrif D

<p>view upstream</p>

<p>view downstream</p>
Position	28° 48.16' S and 17° 58.72' E
Access route	Existing track via Haib River in Namibia to site B, from there narrow river valley and road build-up would be required, resulting in substantial construction impacts; or existing track via Krom River (this track was not investigated during the field survey)
Affected riparian vegetation	<i>Prosopis</i> sp. – <i>Tamarix usneoides</i> woodland on drybank (north- and south-bank), isolated <i>Salix mucronata</i> trees on south-bank, <i>Phragmites australis</i> reed beds
Affected adjacent vegetation	Directly affected by inundation <i>Sisymbrium spartea</i> shrubland on footslopes and sand plain
Topography	Narrow river valley at actual dam site, inland delta related to Krom River joining north-bank just upstream of dam site
Habitats	Mountain slopes, river banks (dry- and wetbank), boulder areas, islands

Existing disturbance	<ul style="list-style-type: none"> ▪ <i>Prosopis</i> species invading ▪ some burned patches on north-and south-bank
Alien vegetation	<i>Argemone ochroleuca</i> , <i>Prosopis</i> species (<i>P. glandulosa</i> and <i>P. velutina</i>), <i>Ricinus communis</i>

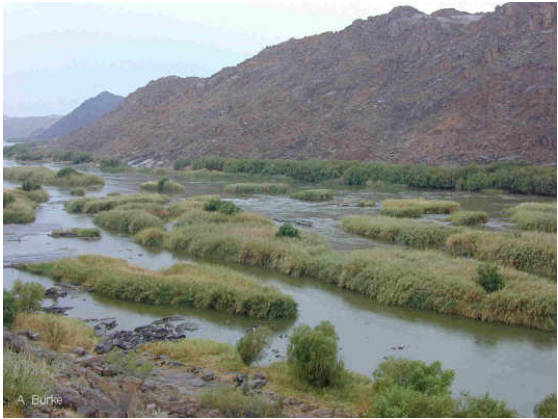
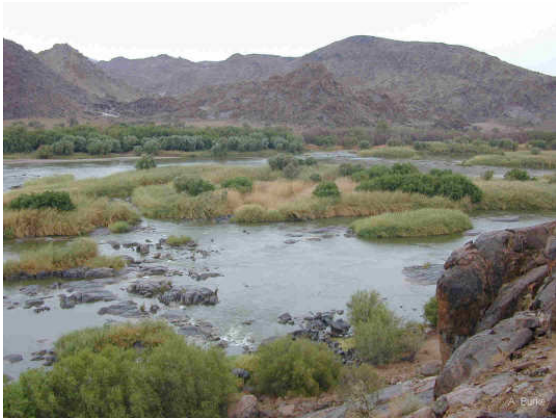
Yas B

<p>view upstream</p>

<p>view downstream</p>
Position	28°31.72' S and 19°35.24' E
Access route	Following existing track to approximately 10 km upstream of dam site on south bank; remaining possible access route extremely difficult with steep slopes reaching to river banks and very narrow sand deposit on south bank. Road along this section would require major built up, possibly blasting and hence pose a major impact.
Affected riparian vegetation	<i>Salix mucronata</i> – <i>Rhus pendulina</i> woodland, <i>Tamarix usneoides</i> woodland, <i>Phragmites australis</i> reed beds
Affected adjacent vegetation	<i>Sisyndite spartea</i> shrubland on sand plain and footslopes
Topography	Narrow river valley
Habitats	Mountain slopes, river banks, boulder areas, backwaters, islands, sand banks
Existing disturbance	<ul style="list-style-type: none"> ▪ localised burned patches of riparian woodland
Alien vegetation	<ul style="list-style-type: none"> ▪ None recorded

Recommendation	Not to be considered as possible dam site due to large impacts associated with access route and disturbance of relatively pristine wilderness area.

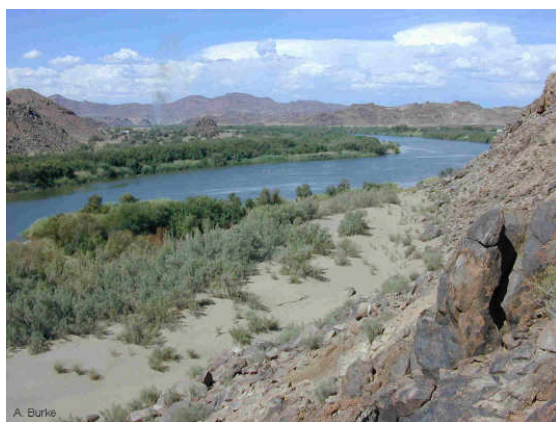
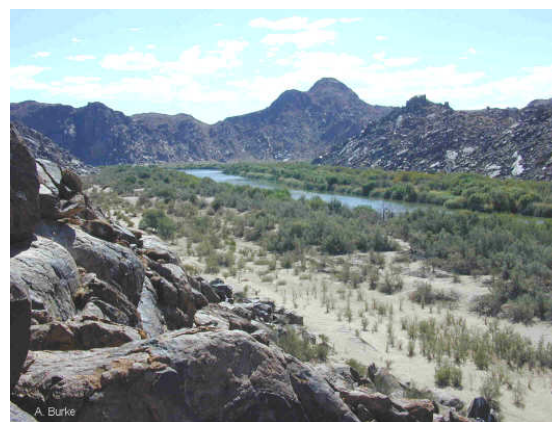
Yas E

view upstream

view downstream

Position	28°31.19' S and 19°41.25' E
Access route	Access along existing track almost to dam site; final section along river bank will require some built up, but likely no blasting.
Affected riparian vegetation	<i>Salix mucronata</i> woodland, <i>Tamarix usneoides</i> woodland on north- and south-banks, <i>Phragmites australis</i> reedbeds
Affected adjacent vegetation	<i>Sisyndite spartea</i> shrubland on sand plain and footslopes adjoining riparian woodlands, <i>Commiphora gracilifrons</i> shrubland on mountain slopes
Topography	Narrow valley at dam site and downstream, widening upstream
Habitats	Mountain slopes, river banks, boulder areas, islands
Existing disturbance	<ul style="list-style-type: none"> ▪ cattle and goat farming ▪ fishing ▪ burned sections of riparian woodland to gain access to river ▪ sections of river showing algae growth (likely due to fertiliser runoff upstream)
Alien vegetation	<i>Ricinus communis</i>

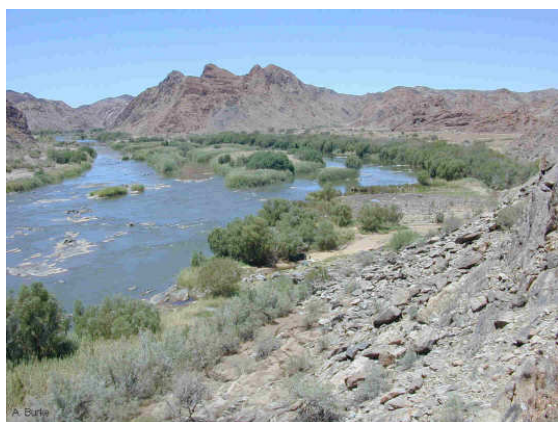
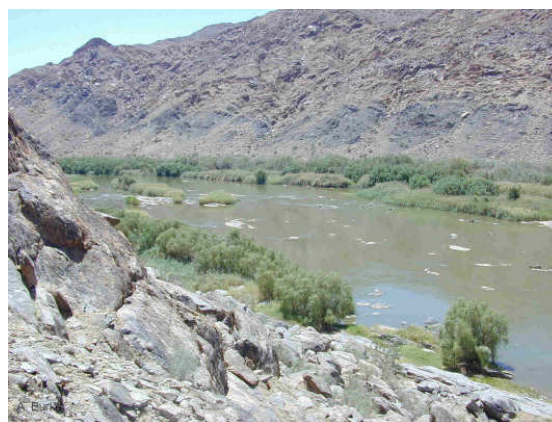
Skuitdrif

view upstream

view downstream

Position	28°30.07' S and 19°46.57' E
Access route	Following access route for Eskom-Nampower powerline, sections of which have recently been built up; last section can follow existing track which may require some minor build up.
Affected riparian vegetation	<i>Salix mucronata</i> – <i>Rhus pendulina</i> woodland, <i>Phragmites australis</i> reedbeds
Affected adjacent vegetation	<i>Sisyndite spartea</i> shrubland and sand plain and footslopes, <i>Monechma spartioides</i> shrubland on mountain slopes
Topography	Narrow river valley
Habitats	Mountain slopes, river banks, sand banks, boulder areas, islands
Existing disturbance	<ul style="list-style-type: none"> ▪ None recorded
Alien vegetation	<i>Ricinus communis</i>

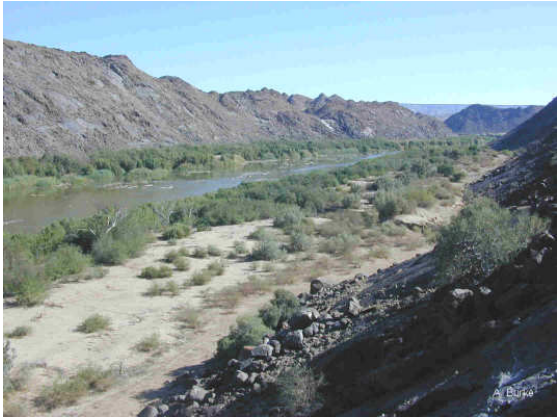
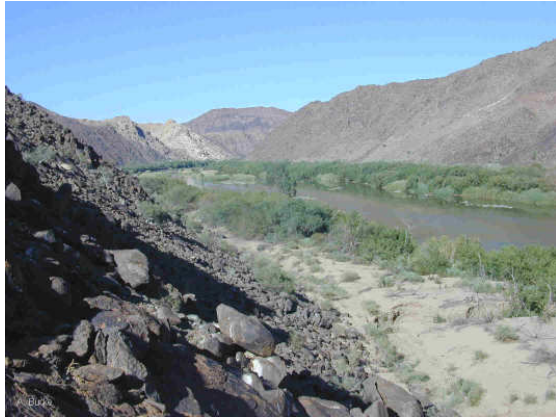
Narries

<p>view upstream</p>

<p>view downstream</p>
Position	28°29.72' S and 19°50.01' E
Access route	Following existing track through tributary on south-bank; final 5 km access difficult on north- and south-bank, as steep mountain slopes reach right to the water
Affected riparian vegetation	<i>Salix mucronata</i> – <i>Ziziphus mucronata</i> woodland
Affected adjacent vegetation	<i>Sisyndite spartea</i> shrubland on sand plain, <i>Enneapogon scaber</i> grassland on mountain slopes
Topography	Narrow valley
Habitats	Mountain slopes, river banks, sand banks, boulder areas, islands, backwaters
Existing disturbance	<ul style="list-style-type: none"> ▪ None recorded
Alien vegetation	<i>Nicotiana glauca</i> , <i>Ricinus communis</i>
Recommendation	Not to be considered as possible dam site due to diverse habitats, relatively pristine status of riparian vegetation, present use as private nature reserve and impacts associated with the building of access route.

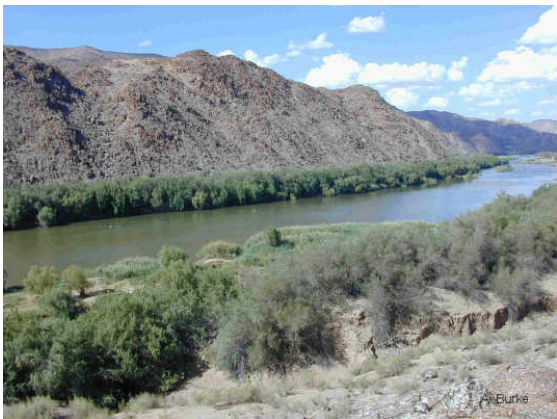
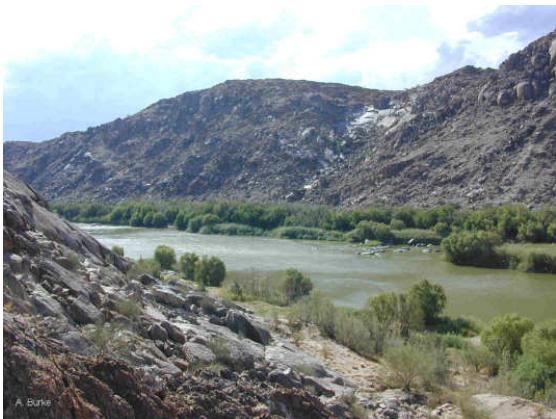
Komsberg

<p>view upstream</p>

<p>view downstream</p>
Position	28°26.37' S and 19°56.45' E
Access route	Following existing track via Daberas farmhouse (South Africa); the last section of the track will require some built up and possibly blasting or removing of few boulders.
Affected riparian vegetation	<i>Salix mucronata</i> and <i>Tamarix usneoides</i> woodland, patches of <i>Phragmites australis</i> and reed beds and <i>Cynodon dactylon</i> on wetbanks and islands, boulders with <i>Gomphostigma virgatum</i> ; recruitment of <i>Rhus pendulina</i> and <i>Salix mucronata</i> on sand banks near river.
Affected adjacent vegetation	<i>Sisymbrium spartea</i> – <i>Zygophyllum microcarpum</i> shrubland and sand plain and <i>Boscia albitrunca</i> shrubland on mountain slopes
Topography	Narrow river valley
Habitats	Mountain slopes, river banks, islands, boulder areas, backwaters
Existing disturbance	<ul style="list-style-type: none"> ▪ None in immediate vicinity of dam site

Alien vegetation	<i>Ricinus communis</i>
Recommendation	Not to be considered as possible dam site due to effect on relatively pristine riverine vegetation and dam position in a National Park.
