**African Transboundary River Basin Support Programme**

# **BASELINE MONITORING OF AQUATIC ECOSYSTEM HEALTH IN THE ORANGE-SENQU RIVER BASIN: FINAL REPORT: PART 1 – SUMMARY REPORT**

**Report No. ORASECOM  
March 2011**

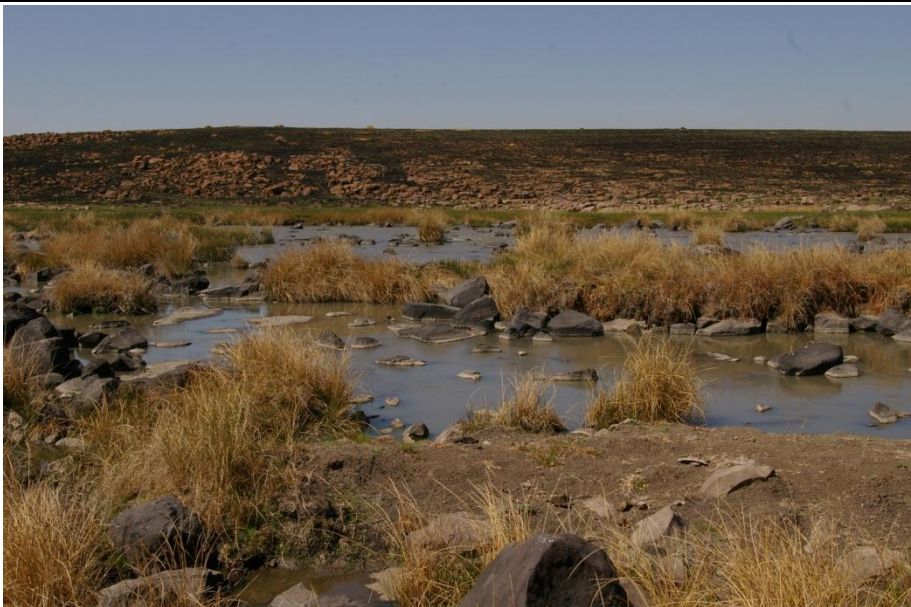
EWR 1, Uitkoms, September 2007

changes due to the interbasin transfer from the Usutu River to the Perdewaterspruit which also raise the base flow from April to October. Occasional fish kills occur in the MRU that could be related to water quality problems. Cattle grazing also occurs in the riparian zone.
<b>Fish</b>	All the expected fish species are still present within this Resource Unit (RU) although the Frequency of Occurrence (FROC) of some species has been reduced from reference conditions. The FROC of <i>L. kimberleyensis</i> has been altered potentially as a result of water quality deterioration as well as habitat deterioration (increased siltation and benthic algae). The FROC of <i>B. anoplus</i> , <i>B. paludinosus</i> and <i>Pseudocrenilabrus philander</i> have also been reduced and relates to loss of cover (vegetation loss as result of bank erosion and sedimentation of substrates) and especially due to the presence of the aggressive alien predator <i>Micropterus salmoides</i> .

<b>Inverts</b>	Sep 07: SASS5 score: 104      No of Taxa: 18      ASPT: 5.8 Apr 08: SASS5 score: 89      No of Taxa: 17      ASPT: 5.2 Key taxa expected but not observed were generally those that are sensitive to water quality changes, such as Perlidae, Leptophlebiidae, Heptageniidae, Gerridae, <i>Centroptiloides bifasciata</i> , Hydracarina, <i>Caridina nilotica</i> and <i>Hydropsyche longifurca</i> . Tricorythidae were more abundant than expected, while Hydropsychidae were less abundant than expected.
<b>Rip veg</b>	This site occurs within the Soweto Highveld Grassland vegetation type, which has an endangered conservation status with 52.7% of the type remaining and only 0.2% protected.
<b>Diatoms</b>	Three diatom samples were taken at the site (September and December 2007, and April 2008) and 2003 diatom data was also available (Taylor, 2004). The overall biological <sup>2</sup> water quality EC is a C, but there are indications that the water quality deteriorates markedly during the months of March and September – November. The Specific Pollution Index (SPI <sup>3</sup> ) during these months indicates an increase in nutrient load, ionic concentrations and organic pollution. Due to the transfer schemes (Heysoppe and Zaaiohoek) that cause elevated base flows there seems to be a dilution effect on the water quality.

PES	Causes <sup>1</sup>	Sources <sup>2</sup>	F <sup>3</sup> /NF <sup>4</sup>
WQ	C	Increased TDS.	Diffuse impacts originating from coal mines. Cattle grazing.	NF
		Some indication of phosphate contamination.	Agriculture.	
		Temperature changes.	Interbasin transfer and Perdewaterspruit.	F
Geom	B/C	Elevated base flows are causing river bank cutting and likely decreased beds and bars.	Interbasin transfers.	F
		Reduced sediment supply.	Small dams.	
Rip veg	A/B	Vegetation removal.	Some trampling/grazing pressure, but minimal impact.	NF
		Exotic invasion.	<10%, <i>Salix babylonica</i> and non-woody weeds mainly.	
		Water quantity.	Reduced sedge cover in marginal zone due to increased dry season base flows, but the same cause has increased sedge cover and vigour in the lower zone.	F
Fish	C	Loss of habitat (decreased SS and SD) diversity as a result of flow modification (especially during natural low flow periods).	Interbasin transfer.	F

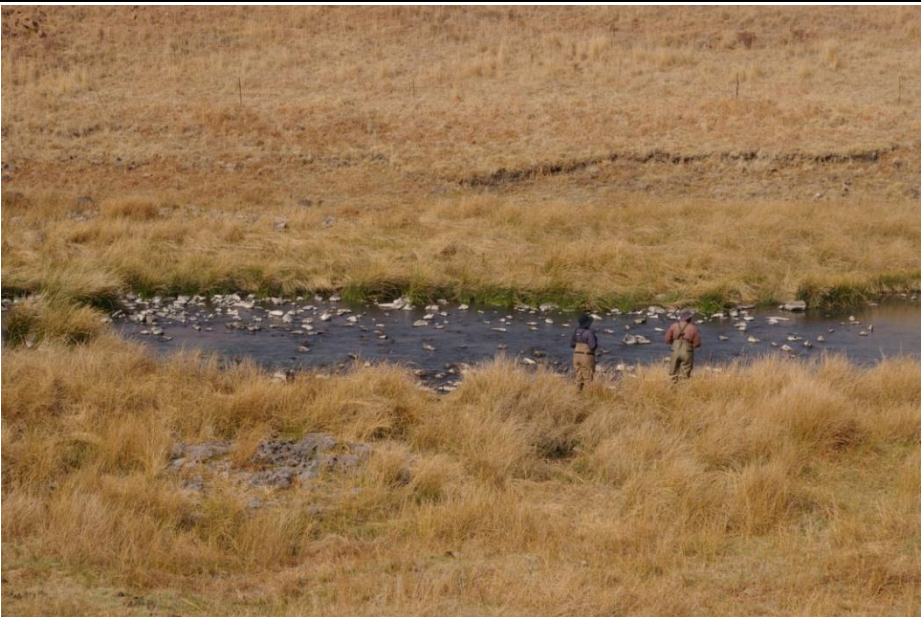
EWR 2, Grootdraai, September 2007

EWR 2 is located in MRU Vaal C which is delineated from Grootdraai to Vaal Dam in a riffle section immediately below Grootdraai Dam. All upstream sediment sources (with possibility of fines, maybe maintained through bottom releases) are being cut off bedrock banks. The channel is incised with paired low benches but terraces are absent. Exotic vegetation is present (20% cover). Fish habitat, flow-depth categories and cover is well represented at site. Due to flow modification unnatural habitat fluctuation is expected as well as unnaturally high abundances of species during migrations.

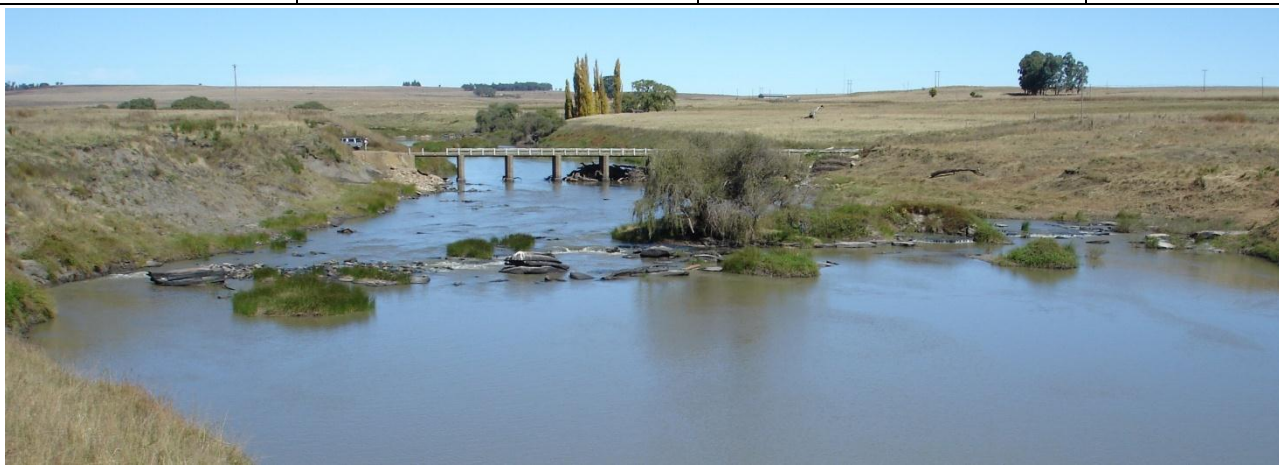
**EWR 3, Gladdedrift, April 2008**

PES	Causes	Sources	F/NF
Inverts	C	Reduced baseflows.	Grootdraai Dam.	F
		Water quality (nutrients).	Agricultural runoff.	NF

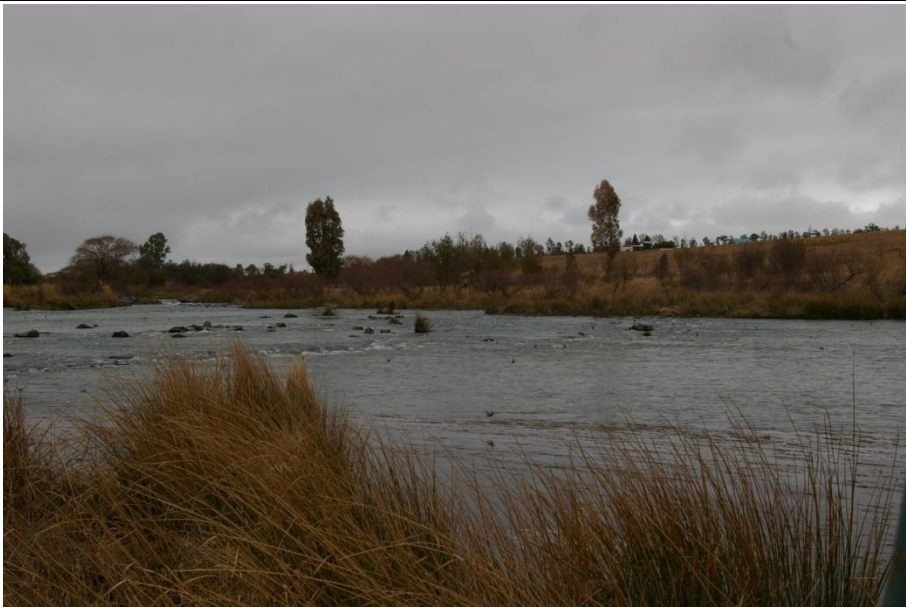
EWR 4, De Neys, August 2007

EWR 4 occurs in MRU Vaal D which is delineated from the Vaal Dam to the Vaal barrage. The site is immediately below Vaal Dam and consists of a bedrock riffle rapid across the river. Morphology is not representative of the reach and site conditions are better than the reach which is mostly affected by the dam/barrage backwaters). Small scale erosion is present due to trampling, and large scale erosion is due to the bridge which has caused minor channel manipulation. Fish habitat is fairly well represented at site and habitat requirements are also met at site. Slow (especially slow-deep (SD)) habitats had to be supplemented by sampling another site. Macroinvertebrate habitat is moderate.

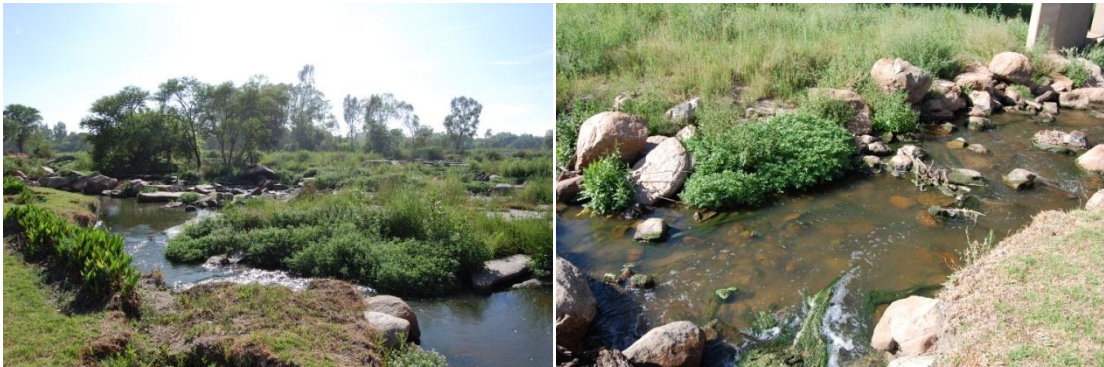
<b>OSAEH 11.13 Good marginal vegetation in the multi channel section of the river.</b>

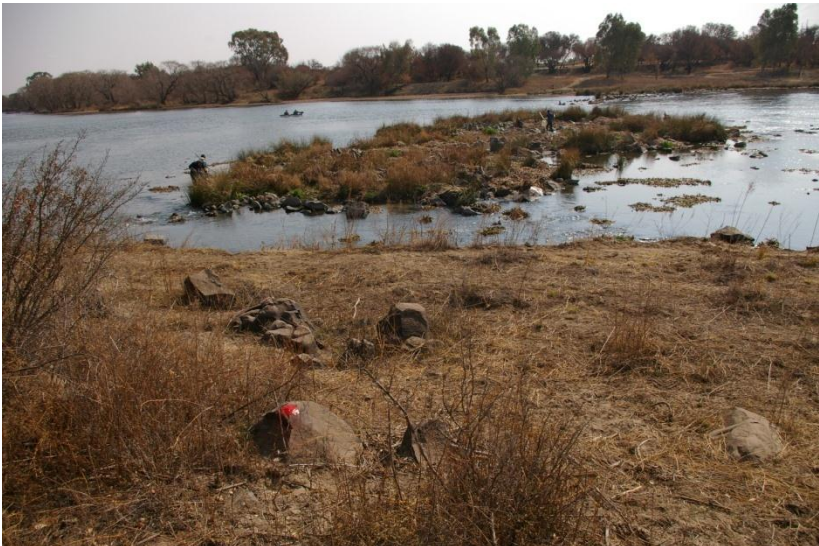
<b>EWR 5, Scandinavia, August 2007</b>

MRU Vaal E is delineated from the Vaal Barrage to the end of the Water Management Area (WMA). The site is 10 km upstream of the Mooi River confluence and the lowest EWR site situated in the Vaal River. The cross-section runs across a bedrock/boulder riffle area, but the reach characterised by generally long pools. Well developed alluvial terraces are present with minor landscaping and boulder piling. There is a high incidence of exotic species in some places with some landscaping occurring on the RB. Fish habitat, flow-depth categories and cover is well represented at site although fast habitats were limited and was supplemented by sampling another site. Macroinvertebrate habitat is moderate.

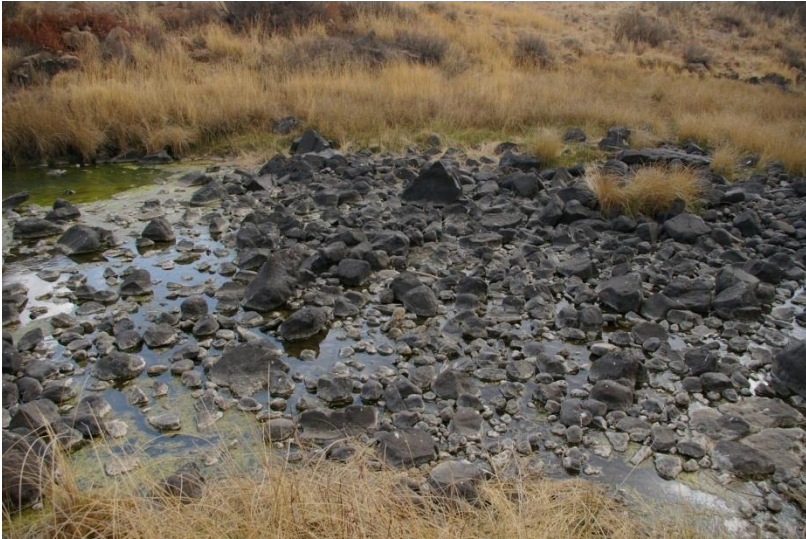
EWR 6, Klip, September 2007

EWR 6 is in MRU Klip C which extends from the Lower Foothill geomorphic zone to Lowland zone. The cross-section runs across a bedrock/boulder riffle area, and there are numerous such areas in the reach. The bed is alluvial (cobble- dominated). The left bank (LB) is bedrock, so no paired terraces occur. There is less than 20% undercutting, and stabilized by vegetation. An unnatural canal on upper zone is present and there is up to 40% cover by exotics. Fish habitat, flow-depth categories and cover is well represented at site but the presence of small weir at the site may alter natural habitat and species composition slightly. Macroinvertebrate habitat is moderate.

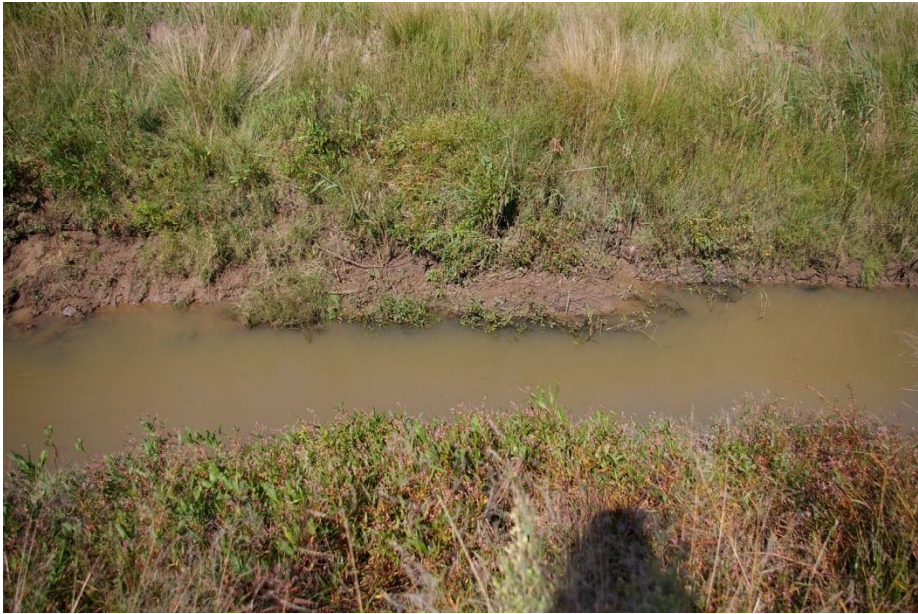
EWR 7, Upper Wilge, April 2008

MRU Wilge A extends from the origin of Wilge River to the confluence with the Nuwejaarspruit and EWR 7 is located in this reach. The site is a meandering floodplain area within an extensive reach, and generally little impacts are present, but Braamhoek pumped storage scheme is under construction in the upper reaches - approx 17 km upstream from the site. The meandering alluvial floodplain system has good morphological cues (ox-bows etc.) Only natural undercutting and slumping was observed on cutting bends of main channel and no channel manipulation was observed at site. Fish habitat, flow-depth categories and cover is well represented at site although very limited stable flow-sensitive habitats are available, although the site is representative of this reach. Non-flow related impacts may have a negative impact on fish species (alien predatory bass) which may reduce the ability of site to sustain these species, and therefore reflect adequate flow conditions. While the channel was sufficient for sampling the floodplain was too extensive. Macroinvertebrate habitat is very poor.

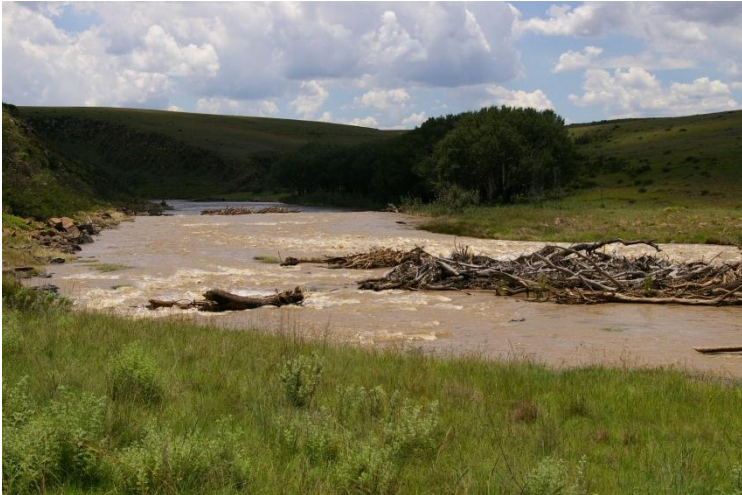
EWR 8, Bavaria, December 2007

EWR 8 in the Wilge occurs in MRU Wilge B which extends from Nuwejaarspruit to the Holspruit. The site is at the beginning of a bedrock gorge and not representative of most of the reach. The bedrock nature of the channel makes the banks insensitive to flow changes, and therefore not a good area for obtaining information on the condition of the river. There are no morphological cues in this predominantly fixed boulder dominated area. There are less than 10% exotic species at the site, and poplars are aggressive invaders locally. No channel manipulation was observed at site. Fish habitat, flow-depth categories and cover is well represented at site, but macroinvertebrate habitat is poor.

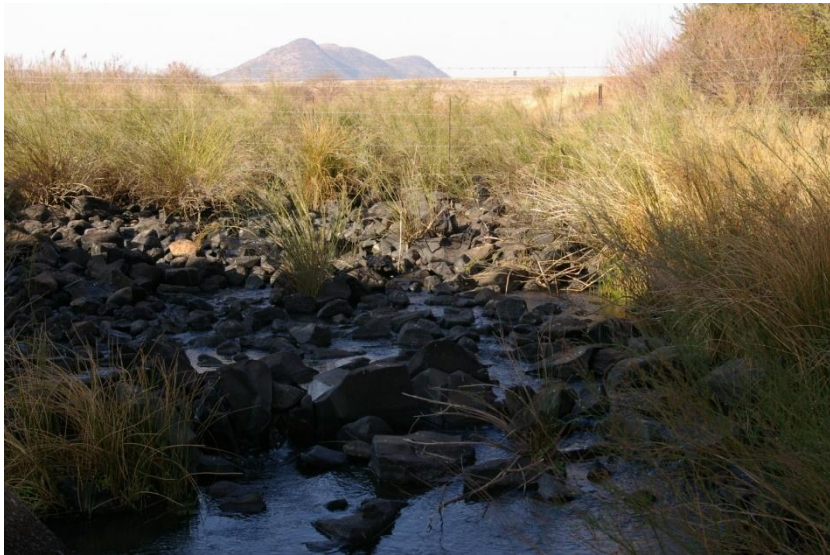
<b>EWR 9, Suikerbos US, August 2008</b>

EWR 9 is situated in the upper reaches of the Suikerbosrand River, and falls within MRU Suiker A delineated as from the origin of river to the confluence with Blesbokspruit River. The site is in a bedrock rapid, and although the reach is generally characterised by long pools, there are a number of such rapids in the reach. Some morphological cues present in the upstream pool area - upper terrace is paired on opposite the bank and the lower bench is annually flooded. Some channel manipulation from the construction of bridge downstream was observed and there is 40% exotic species coverage. Fish habitat, flow-depth categories and cover is well represented at site and macroinvertebrate habitat is moderate.

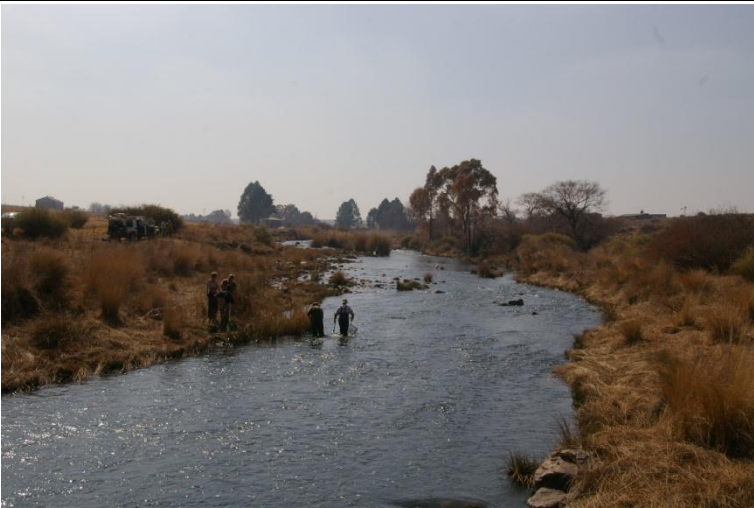
<b>EWR 10, Suikerbos DS, August 2008</b>

MRU Suiker B is delineated as the Suikerbosrand River reach from the Blesbokspruit confluence to the Vaal River confluence. EWR 10 is below the Blesbokspruit confluence and the morphology is generally representative of the reach, but impacts concentrated around the road/bridge access results in the banks being in a poorer condition than generally seen along the reach. Upper and lower terraces are paired on opposite bank. Some channel manipulation from roads is present although this has a minor influence on the site. There is up to 60% exotics in places. Fish habitat, flow-depth categories and cover is well represented at site while excellent macroinvertebrate habitat is present.

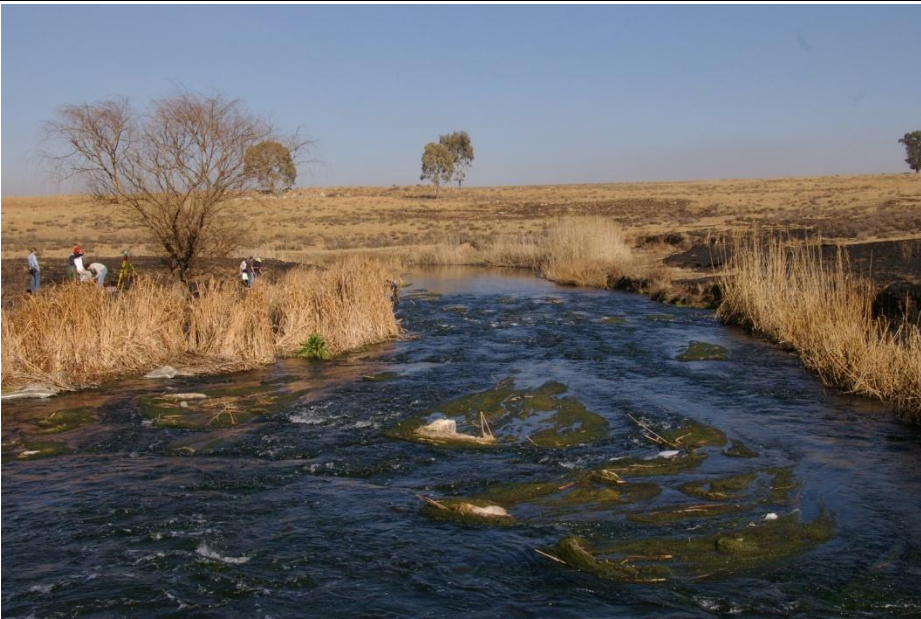
<b>EWR 11, Blesbokspruit, August 2008</b>

The whole Blesbokspruit River has been delineated as one MRU, MRU Bles A. The site morphology is generally representative of the reach, but impacts concentrated around the road/bridge access results in the banks being in a poorer condition than generally seen along the reach. There are approximately paired terraces on both banks and instream features are scoured out (probably due to increased flows and recent floods). Some channel manipulation from low and high-level bridges upstream was observed and there is up to 20% exotics in places. Fish habitat, flow-depth categories and cover is well represented at site. Non-flow related impacts may have negative impact on semi-rheophilic species (reduced water quality, extensive algal growth on substrate) which may reduce the ability of site to sustain these species. Macroinvertebrate habitat is poor.

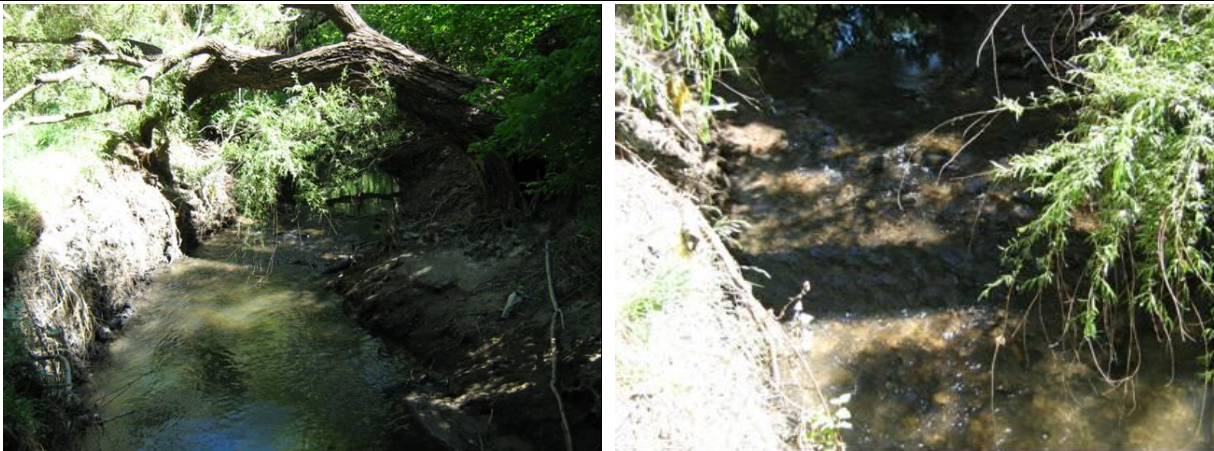
OSAEH 11.3. Site and riffle habitat

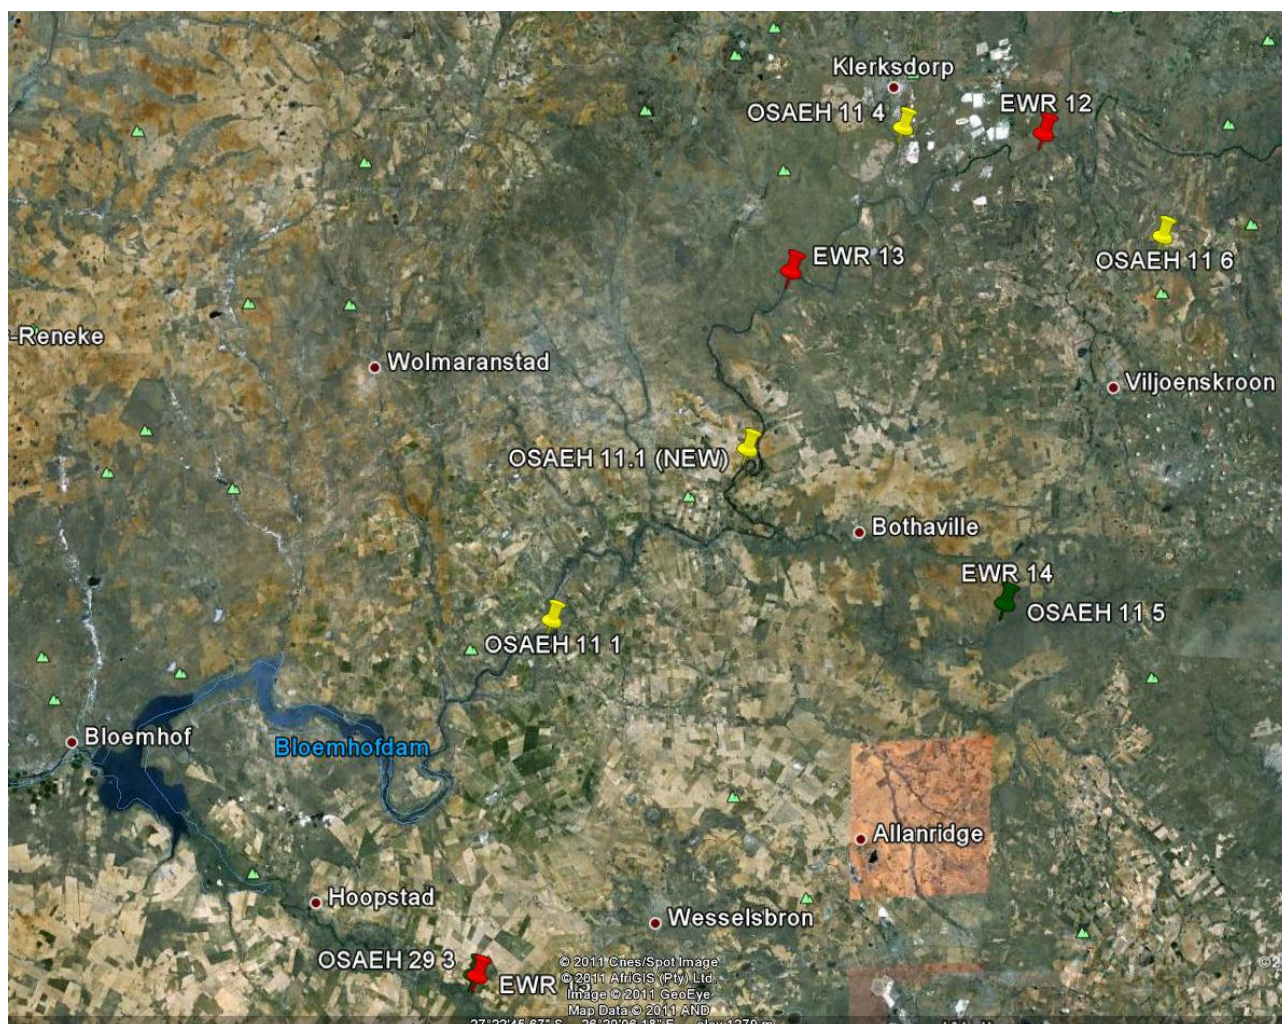
**Figure 18.1 OSAEH monitoring and EWR sites occurring within the Middle Vaal WMA (WMA 9) (Google Earth image, 2010)**

Figure 18.1 provides the locality of the EWR sites as well as the OSAEH sites that occur in the Vaal River where the green pins represent the OSAEH monitoring sites, and the red pins represent the EWR sites assessed during 2010. Site information is provided in Table 18.1.

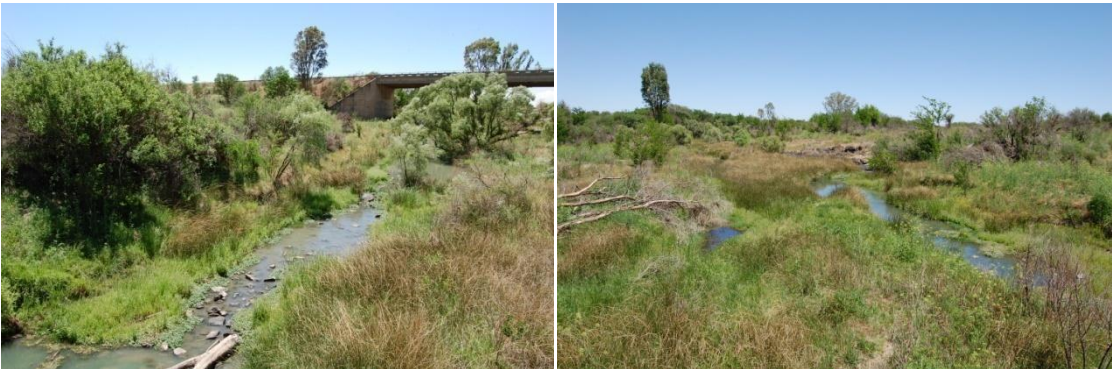
Site OSAEH 11.6 indicating excellent marginal vegetation but poor stream flow

<b>RHENOSTER RIVER</b>				
OSAEH 11.6	MRU Rhenoster C	B/C	OSAEH 11.6 is situated in the lower reaches of the Rhenoster River, and has good habitat available for the full suite of biological components to be monitored. This site is a valuable monitoring site for future monitoring programmes as it is located in a tributary and has many upstream impacts. As the Vaal River main stem has deteriorated water quality, tributaries play an important role in diluting these impacts and providing refugia for biota.	JBS15
<b>SCHOONSPRUIT</b>				
OSAEH 11.4	MRU Schoon-spruit D	C	During 2003 – 2005 an Intermediate Reserve Determination Study was commissioned by the Free State Regional Office, as part of a Catchment Management Strategy Development for the Schoon- and Koekemoerspruit catchments. As the Schoonspruit has a major influence on the Vaal River main stem, OSAEH 11.4 is an important site in terms of a future monitoring programme. The lower reaches of the Schoonspruit are heavily impacted by anthropogenic activity and water quality is deteriorated. Substantial data is available on this river and the site is suitable for monitoring the full suite of biotic components.	JBS16

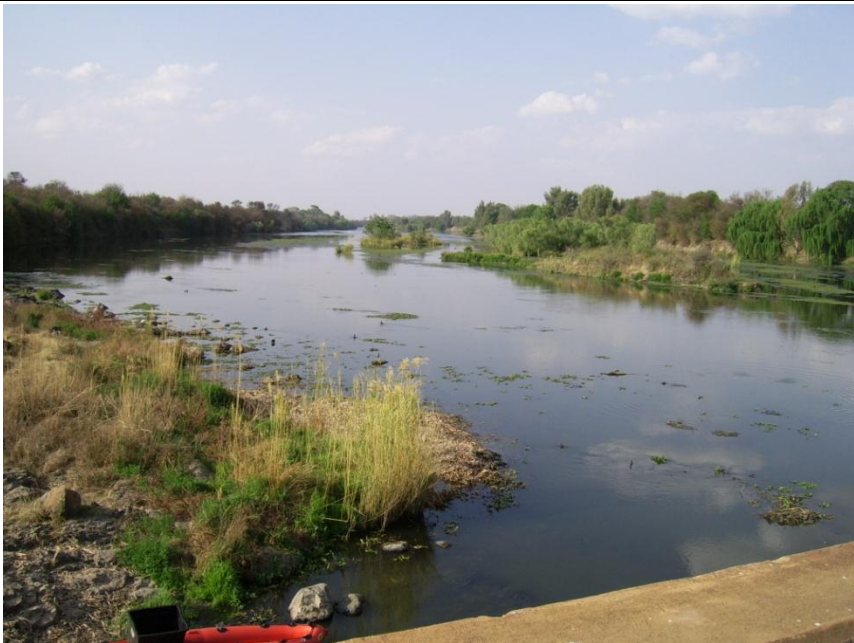
<b>EWR 12, Vermaasdrift</b>

EWR 12 is situated downstream of Parys and upstream of the confluence with the Koekemoerspruit at Vermaasdrift on the main stem of the Vaal River. The site is a single thread straight channel with a flat bed which is alluvial controlled. A fixed boulder floor with sand dominates the reach. Fish habitat is well represented at site as well as flow-depth categories and cover. Macroinvertebrate survey habitat availability is moderate at EWR 12 and is not a limiting factor of macroinvertebrate diversity. The site is not ideal for vegetation assessment as vegetation in the area has been disturbed by the construction of the bridge at Vermaasdrif and is not representative of the vegetation along this reach of the Vaal River.

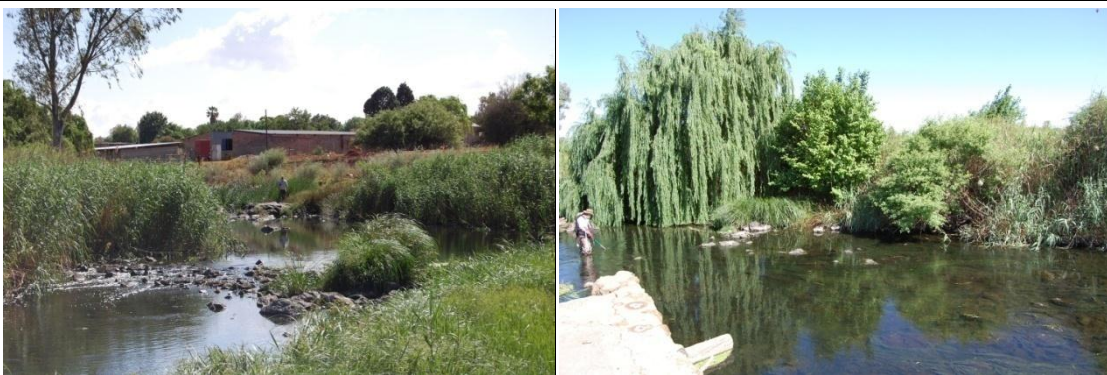
Site OSAEH 11.4 indicating a riffle section as well as dense algal growth on the substratum.

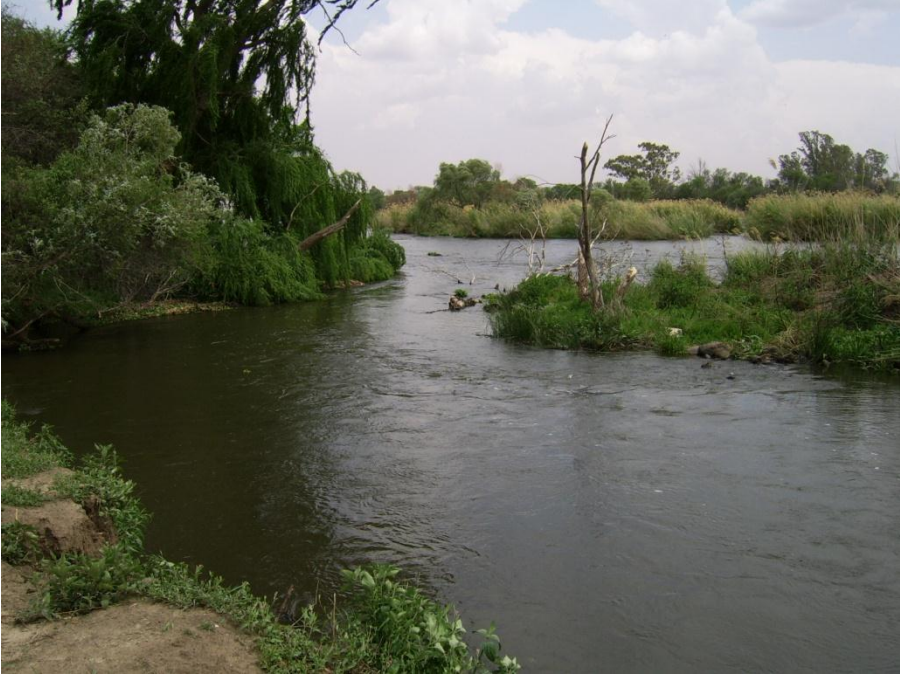
<b>EWR 13</b>

Fish habitat is well represented although unnatural habitat fluctuations may occur due to upstream weir and an unnatural high abundance of species during migrations may occur. Macroinvertebrate survey habitat availability is good at EWR 13 and not a limiting factor of macroinvertebrate diversity. The site is ideal for vegetation assessment as vegetation in the area of the site is representative of the vegetation of the reach. Land use in the area is predominantly agricultural and pastoral farming and this has impacted on the site with regard to exotic species and possibly increases in nutrient levels in the river itself.

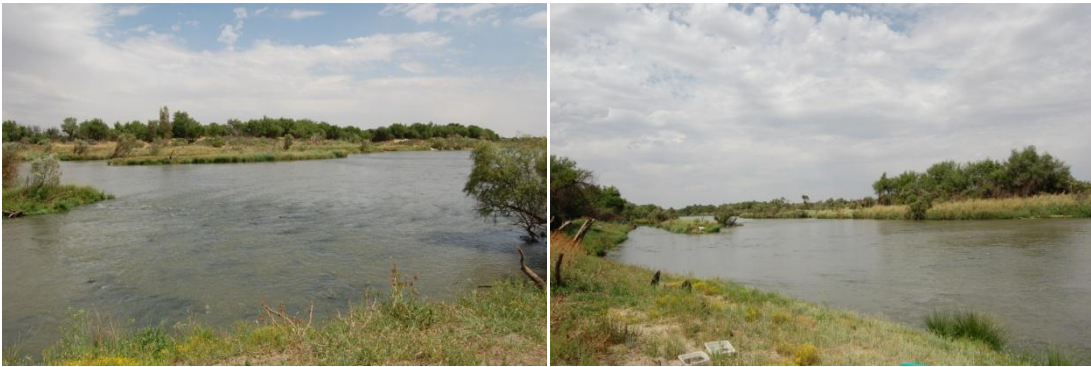
<b>Site OSAEH 11.1 indicating extensive runs over mainly cobble substrate.</b>

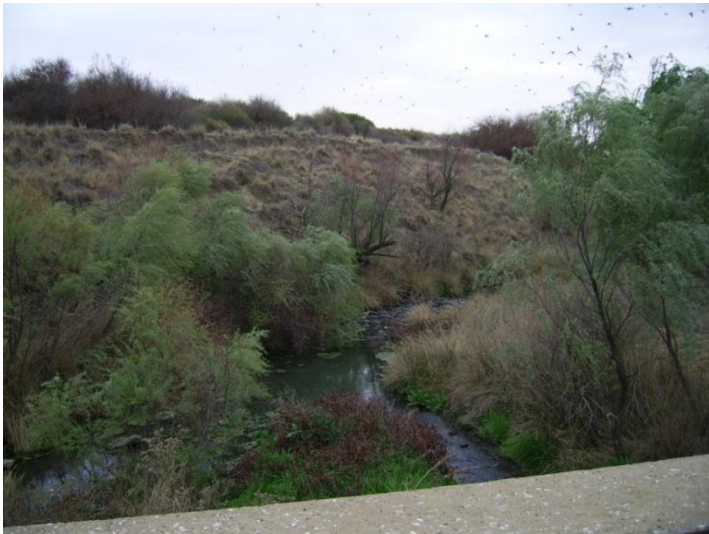
EWR 14, narrow main channel with cobble dominated riffle.

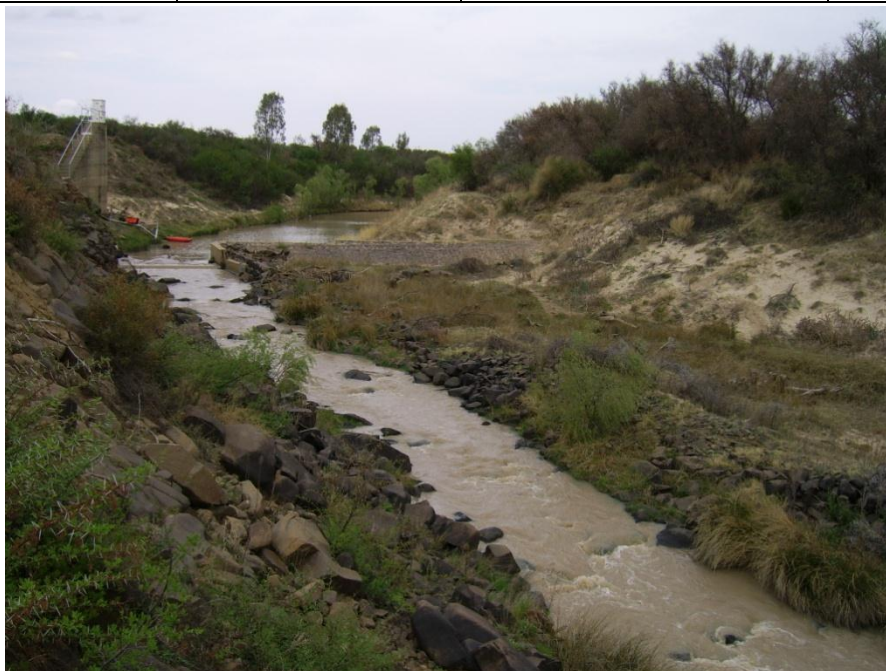
EWR 15, shallow cobble dominated rapid area

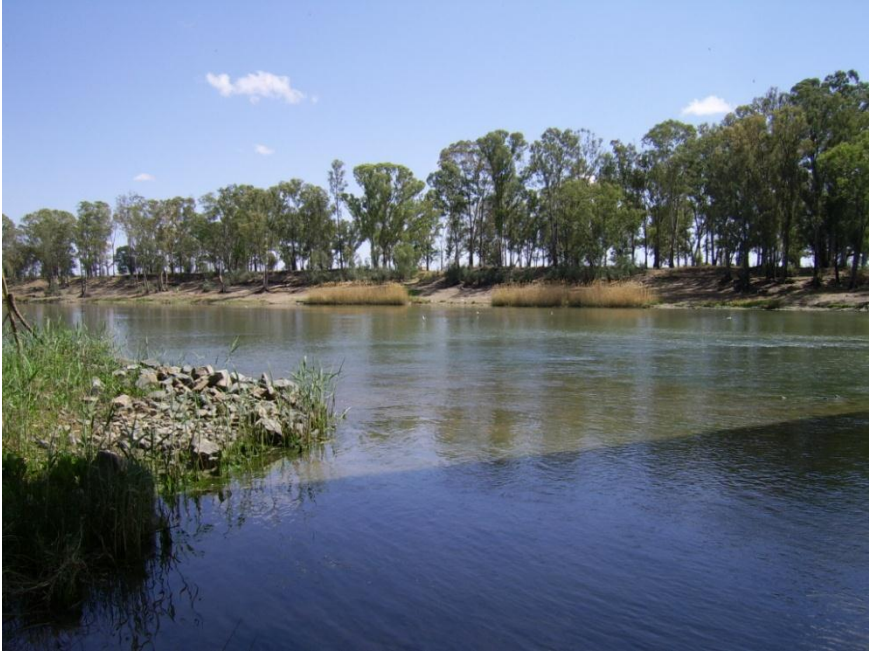
EWR 16, single thread channel with cut banks.

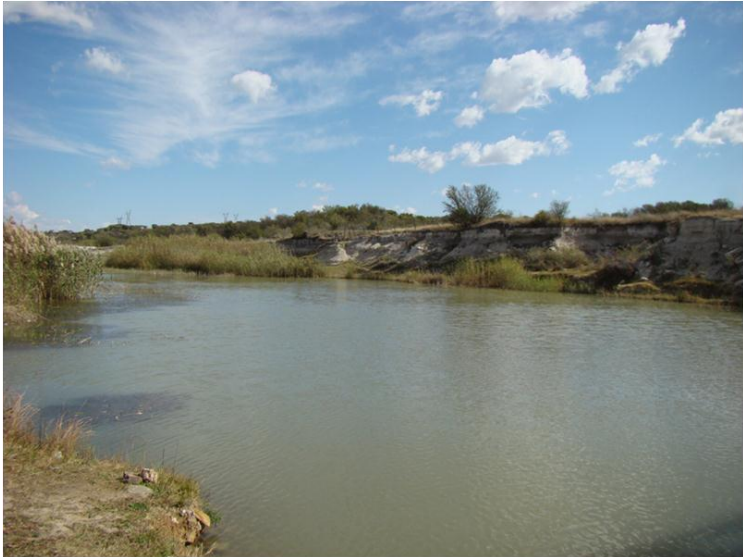
EWR 17, Lloyds weir. Trampling and grazing pressure are evident along both banks.

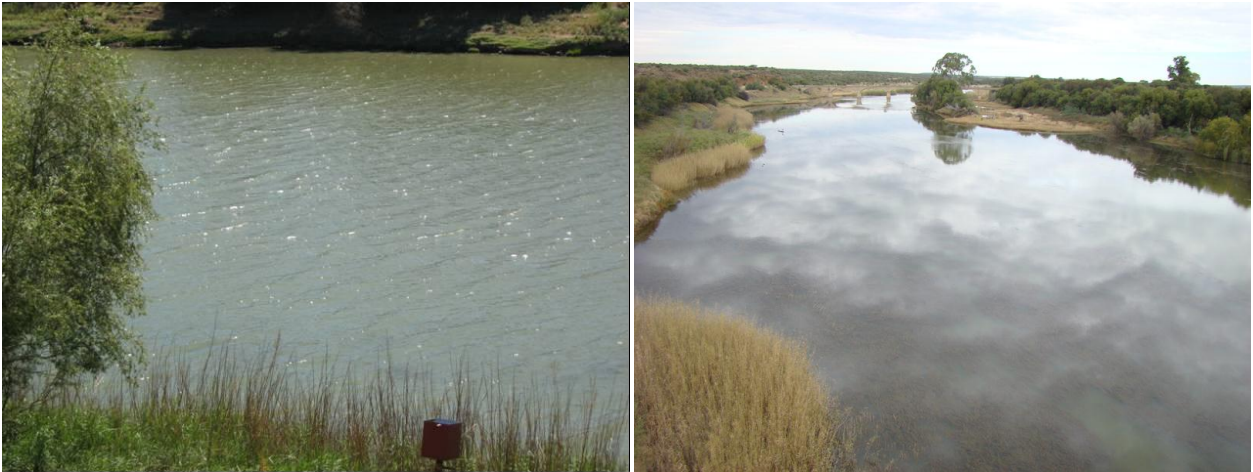
<b>EWR 18, Schmidtsdrift. Left: 2010 - Uniform, deep, wide channel (SD dominant). Right: 2007 - <i>Myriophyllum spicatum</i> has colonised and taken over the aquatic habitat.</b>

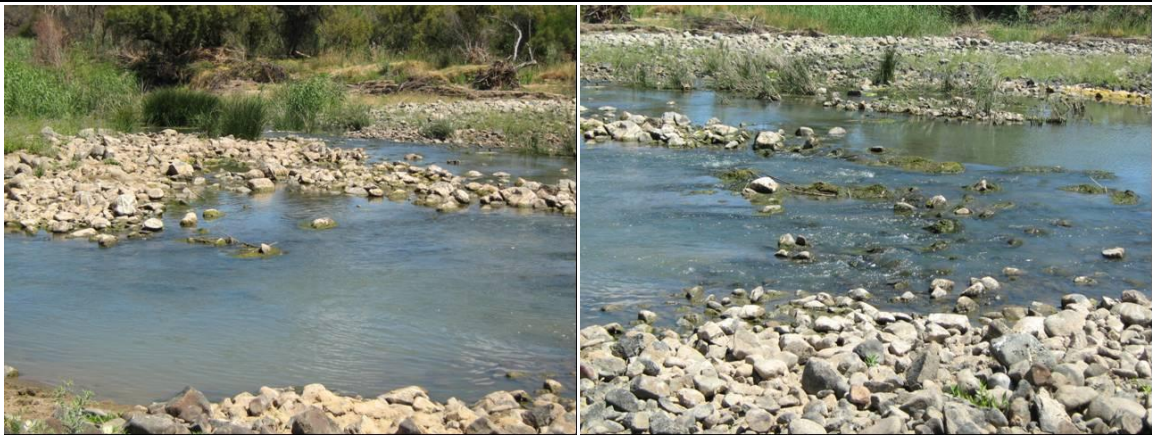
<p>OSAEH 26.1. Left: Small rapid and riffle in Vaal River below Douglas Weir – very good site and habitat diversity for fish assessments (note benthic growth on rocks). Right: Riffle, run and glide habitats with cobbles, rocks and sand substrate.</p>

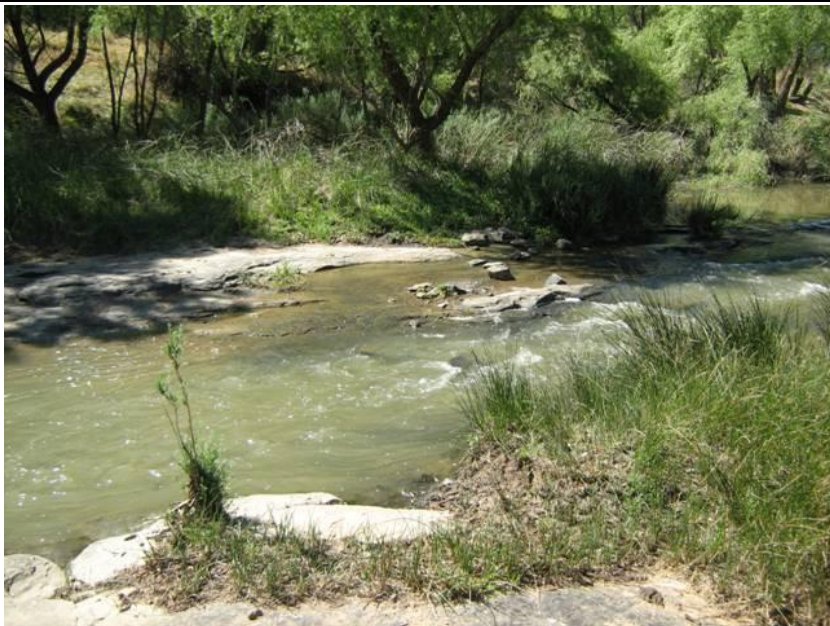
OSAEH 11.18, Modder River – Riffle and run over bedrock.

<b>MODDER RIVER</b>				
OSAEH 11.18	MRU Riet C1	D	OSAEH 11.18 is located downstream of Botshabelo and Thabu Nchu but upstream from Bloemfontein. It is the only OSAEH site situated in the upper reaches of the river and should be included as a biomonitoring site. The habitat at this site is good and the full suite of biological components can be monitored. This site will be a good monitoring site to detect and monitor on-going impacts which include impacts from sewage works, interbasin transfer, and Rustfontein Dam upstream.	JBS24

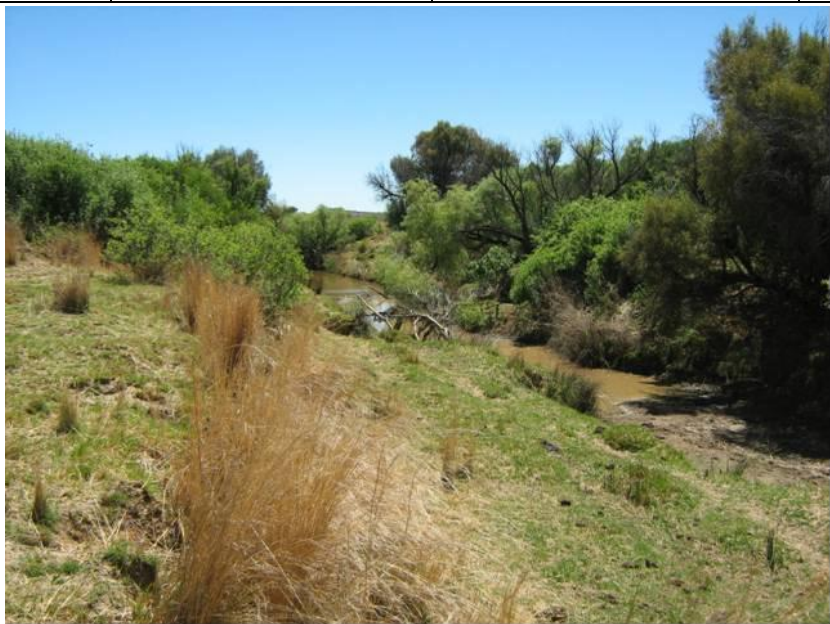
OSAEH 11.22, Korannaspruit – large pool with riparian vegetation overhang.

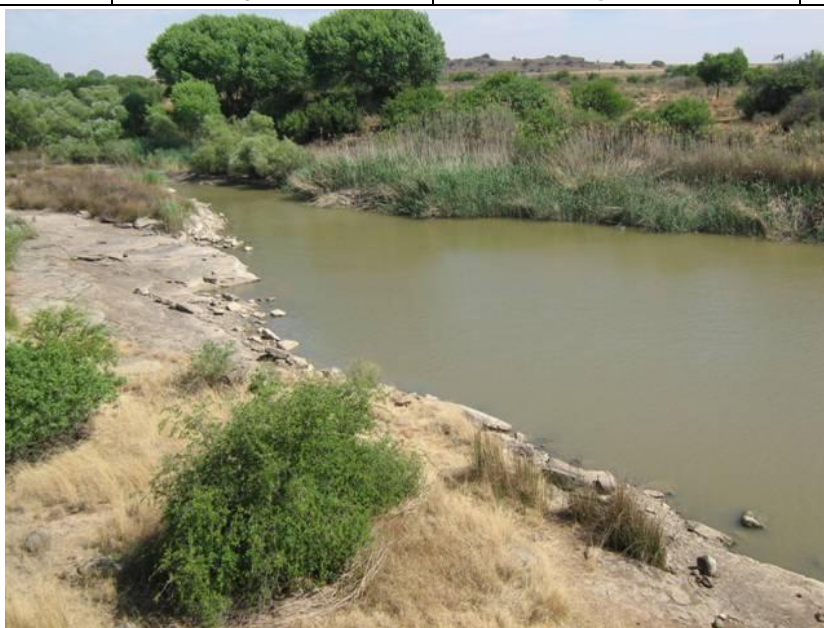
OSAEH 26.10, Riet River. Large deep pool below bridge with bedrock and rocks, as well as marginal vegetation for cover.

<b>RIET RIVER</b>				
OSAEH 26.10	MRU Riet A	D	The site has adequate habitats for the full suite of biological components to be monitored. This site is also an EWR site (IFR 03) and was assessed during the Reserve study in 2003. Although the reach represents a relatively unimpacted part of the Riet River, the EWR assessment resulted in a PES of a D. The current assessment also indicates impacts relating to anthropogenic activities. As the water quality of the Riet River is deteriorated this site should be included as a future monitoring site to detect ongoing impacts especially relating to impaired water quality.	JBS22
OSAEH 29.5	MRU Riet D	C	OSAEH 29.5 is the most downstream site within the Riet River, and is located just downstream of Ritchie at the same location as EWR 19. This reach was identified as a priority reach for maintaining the integrity of the Lower Vaal. Therefore it is an ideal site for detecting impacts from upstream anthropogenic activities originating from the Modder and Riet Rivers. The site occurs in the Mokala National Park on the LB of the river.	JBS23

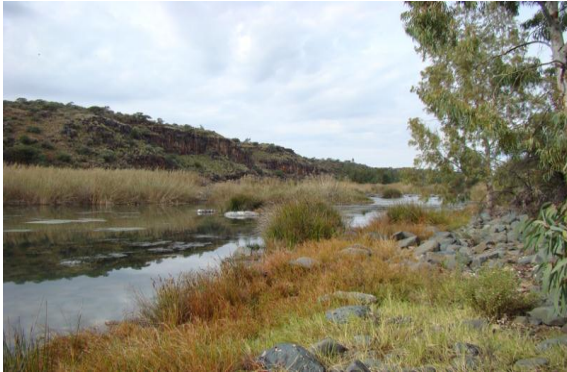
<b>OSAEH 29.5, Riet River, 2007</b>

OSAEH 29.5 is situated in the lower reaches of the Riet River, below Ritchie in MRU Riet D which is delineated from Riet River confluence with Modder River to the inflow into Douglas Barrage and lies within Mokala National Park. The catchment area is dominated by irrigated agriculture. The dominant substrate at the site is bedrock and boulder. Cobble, boulder and rocky substrate is very abundant for cover for aquatic biota. Adequate flow was present at the time of sampling. Large pools for fish refugia were present with abundant marginal vegetation consisting of sedges and reeds and GSM biotope occurs at the site. Good habitat diversity for bio-monitoring purposes is present. Riparian vegetation consists of trees, shrubs, grasses, sedges and reeds. No large dams occur upstream but small weirs are present. The surrounding land use is natural veld for the game reserve.

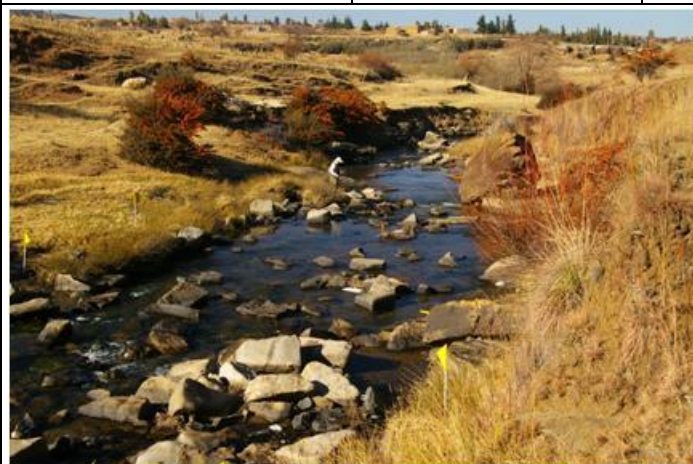
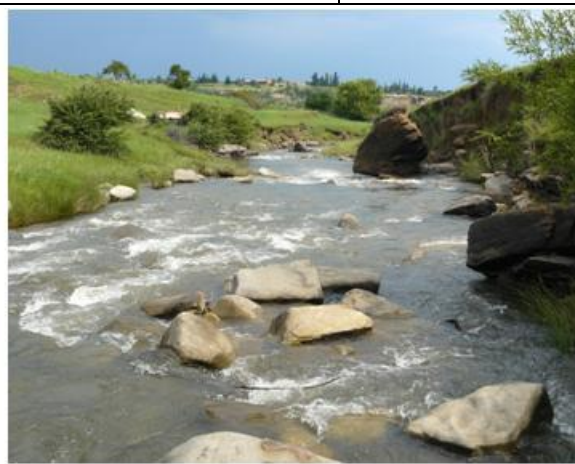
EFR C5, Caledon River. The site under different flow conditions.

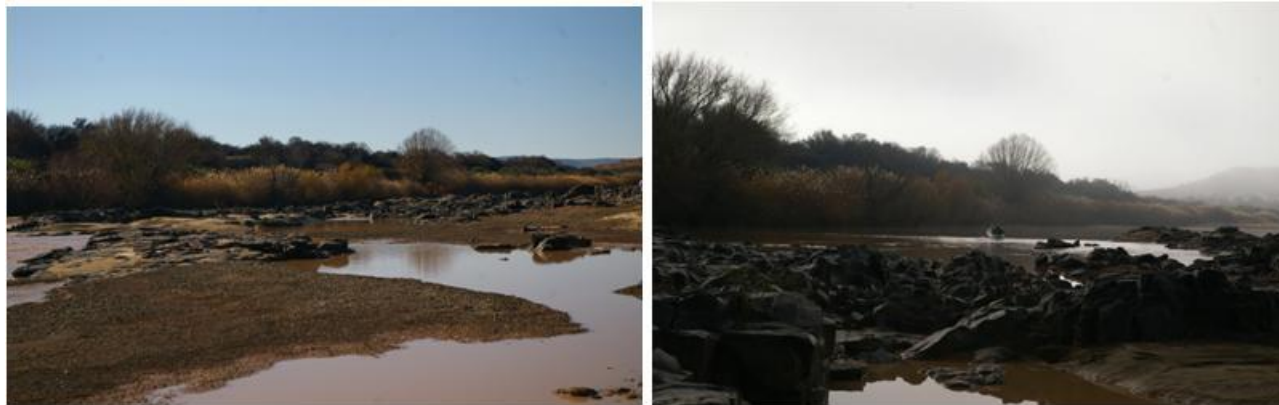
**EFR C6, Upper Caledon River. Channel substrate includes boulder, bedrock, cobble and sand.**

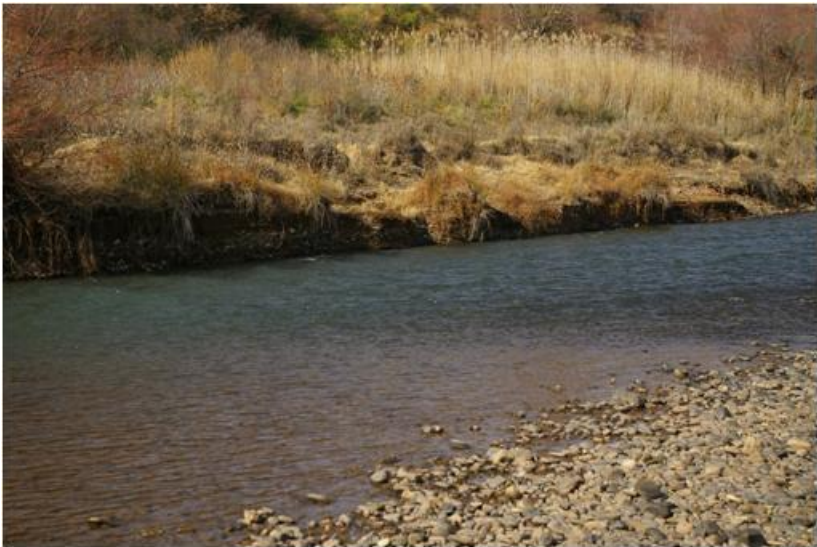
EFR K7, Lower Kraai River. Cobble/gravel bed dominated riffle.

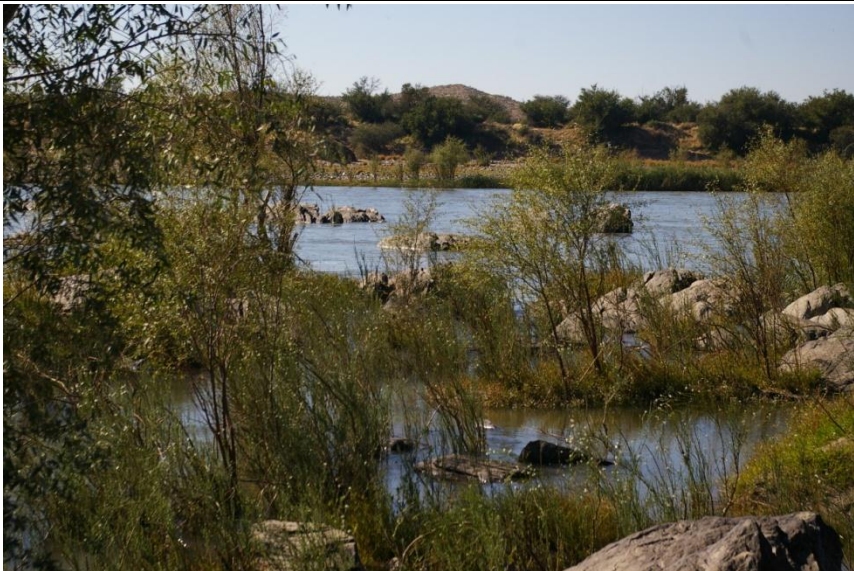
<b>EFR O2, Lower Orange River. There is a high degree of physical habitat diversity associated with the numerous distributary channels at this site.</b>

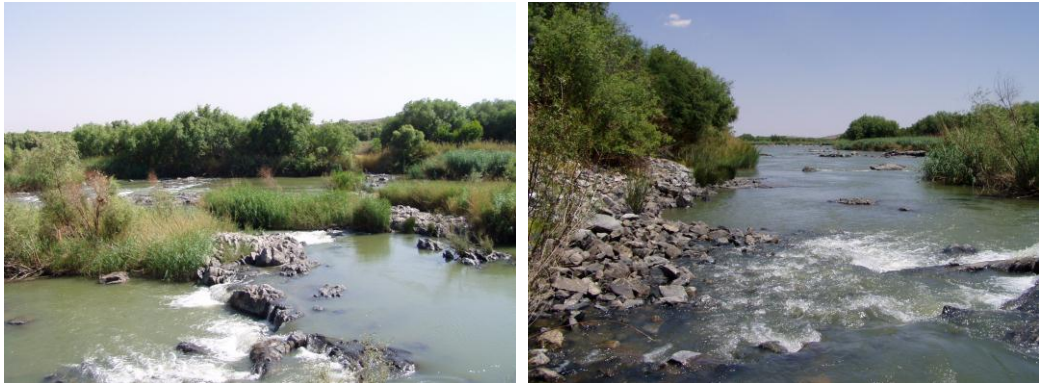
The site is situated approximately 0.4 km downstream of Gifkloof Weir and falls within MRU D as delineated in WFA (2010a). The river has a wide river valley, with low-energy fluvial environment. Sediment banks are present, mainly colonized by *Phragmites*. Although the surrounding environment consists of undulating, rocky hills, the river bank is situated on a steep slope with patches where terraces have formed. The riparian vegetation formed a thicket, with the exotic, *Prosopis glandulosa* var. *glandulosa* as the most prominent species present. Various habitat types were available at the site namely stones in current (rapids and riffles), marginal vegetation and a limited area of gravel and sand. The macro-channel width was >50 - 100 m and the active channel and surface water width was 20 – 50 m. The substratum in the river was mostly bedrock, boulders, cobbles and pebbles with limited sand and gravel.

Rapids and Riffles at OSAEH 26.17, Lower Orange River
