**African Transboundary River Basin Support Programme**

# **BASELINE MONITORING OF AQUATIC ECOSYSTEM HEALTH IN THE ORANGE-SENQU RIVER BASIN: FINAL REPORT: PART 1 – SUMMARY REPORT**

**Report No. ORASECOM  
March 2011**

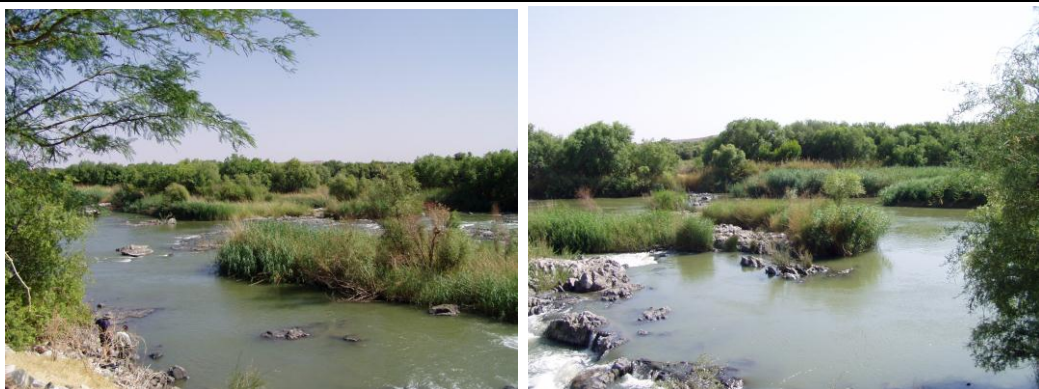
Marginal vegetation at OSAEH 26.17, Lower Orange River

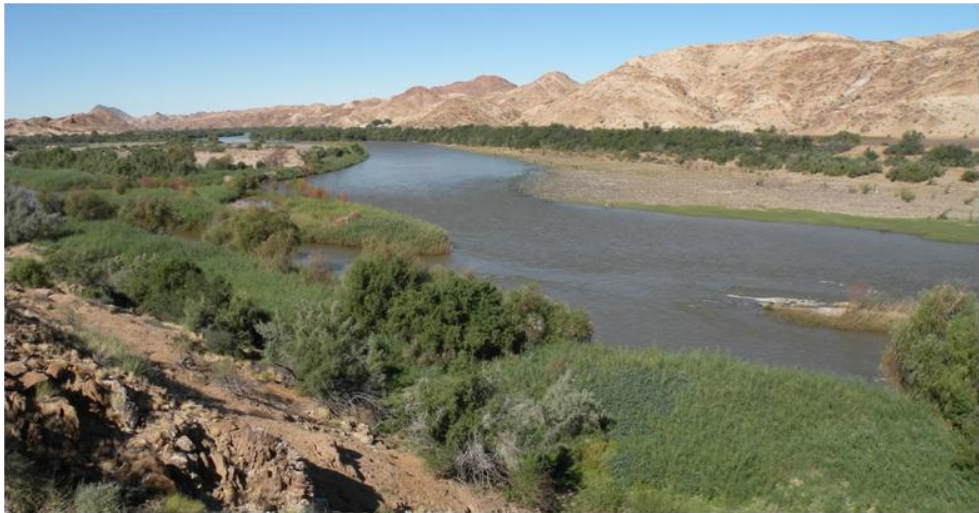
EFR O3, Lower Orange River. Large cobble bars and small fines deposits are present.

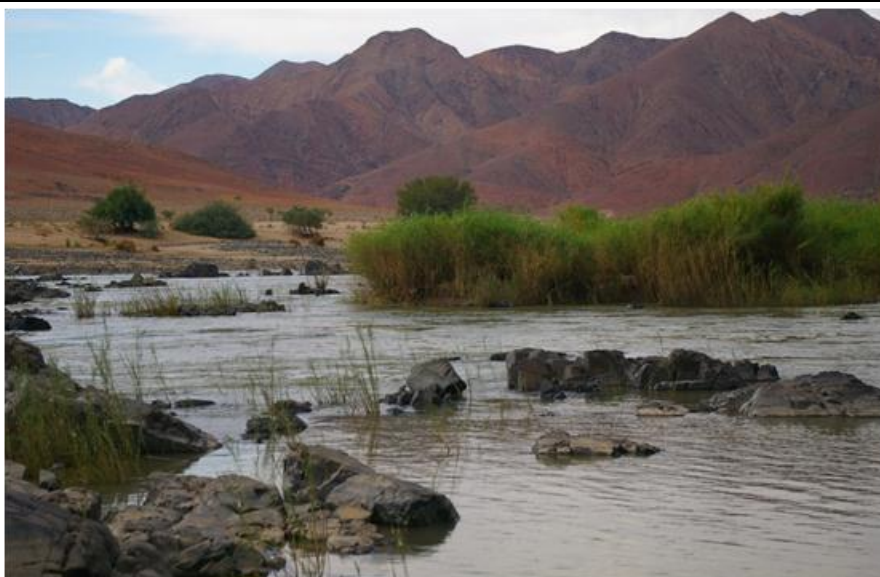
**EFR O4, Lower Orange River. There is a mix of cobbles, gravels and fine sediment deposits within the bedrock-controlled reach.**

OSAEH 28.4	MRU Orange F	C	EFR O4 and OSAEH 28.4 are at the same location and in a better condition than the rest of the reach. Agricultural return flows and mining activities are impacting on water.	JBS35
OSAEH 28.5		B/C	Situated at Sendlingsdrift and suitable site to monitor agricultural impacts.	JBS36

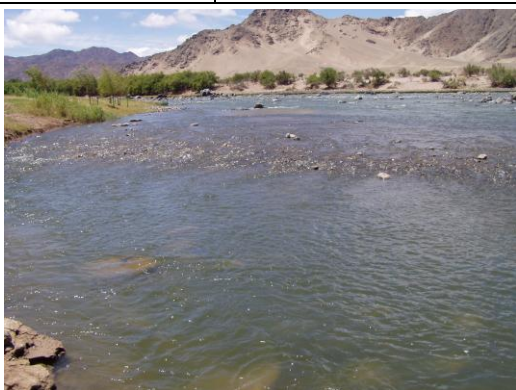
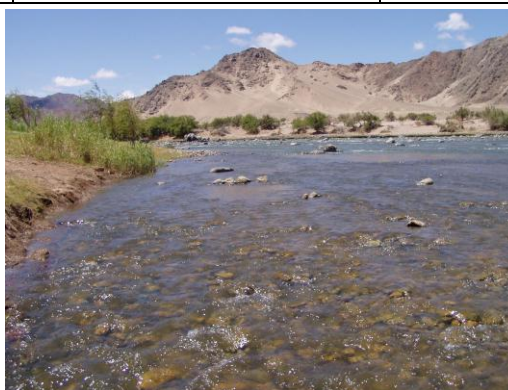
The site is situated approximately 130 km downstream of Vioolsdrif Weir in the lower section of the Orange River (downstream of Augrabies Falls to the estuary) where the river flows through the Orange River Gorge EcoRegion. The site is located on the river's mainstem, at the exact point where it is joined by the south flowing Boom River. The Boom River was however dry at the time of sampling, and no pools or other surface water were evident. The river flows in a wide valley, with low-energy fluvial environment, and big boulders and rocks in the main channel. Sediment banks are present, mainly colonized by *Phragmites*. These islands are habitat to many bird species.

**Rapids and Riffles at OSAEH 28.5, Lower Orange River**

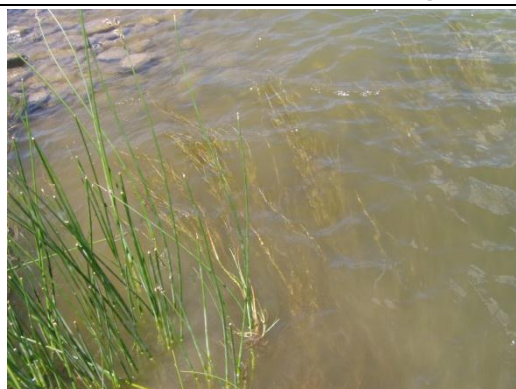
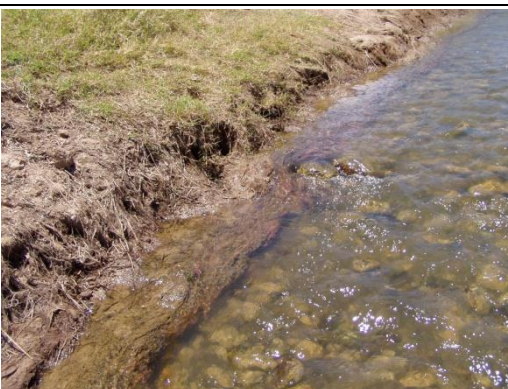
**Marginal vegetation at OSAEH 28.5, Lower Orange River**

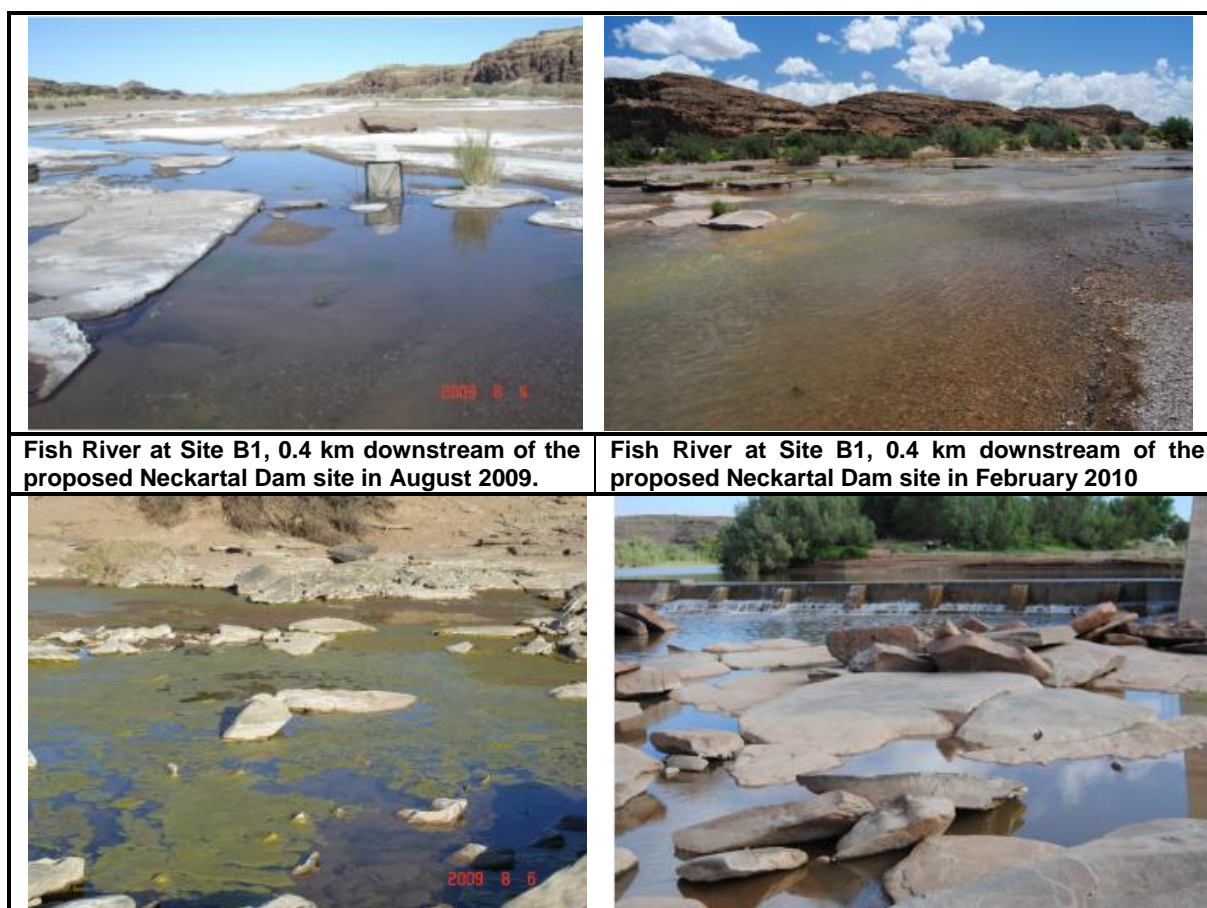
Fish River at Seeheim (Site B2) in August 2009.	Fish River at Seeheim (Site B2) in February 2010.

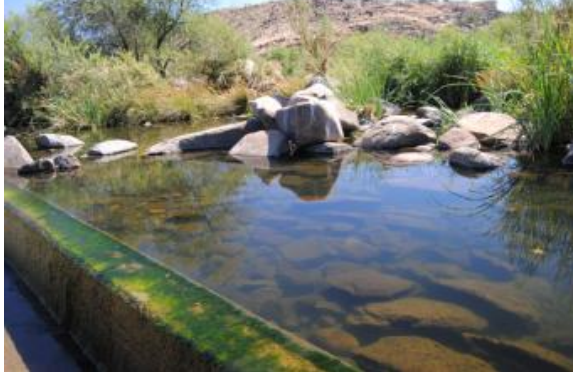
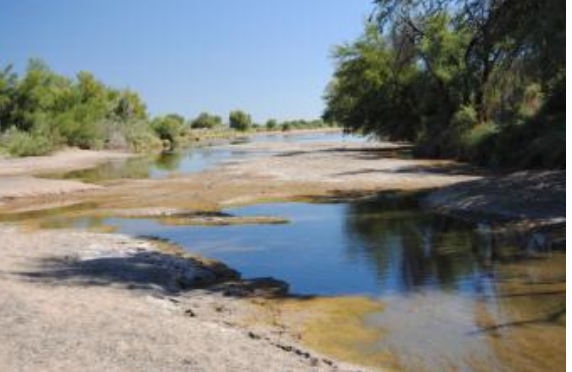
Löwen River, immediately downstream of Naute Dam (Site B3), in February 2010.	Löwen River, 14.5 km downstream of Naute Dam, in February 2010.
