ORASECOM report: ORASECOM/001/2015

# ORANGE-SENQU WATER RESOURCES QUALITY JOINT BASIN SURVEY 2 (JBS 2) – FINAL REPORT AQUATIC ECOSYSTEM HEALTH AND WATER QUALITY MONITORING IN 2015

November 2015

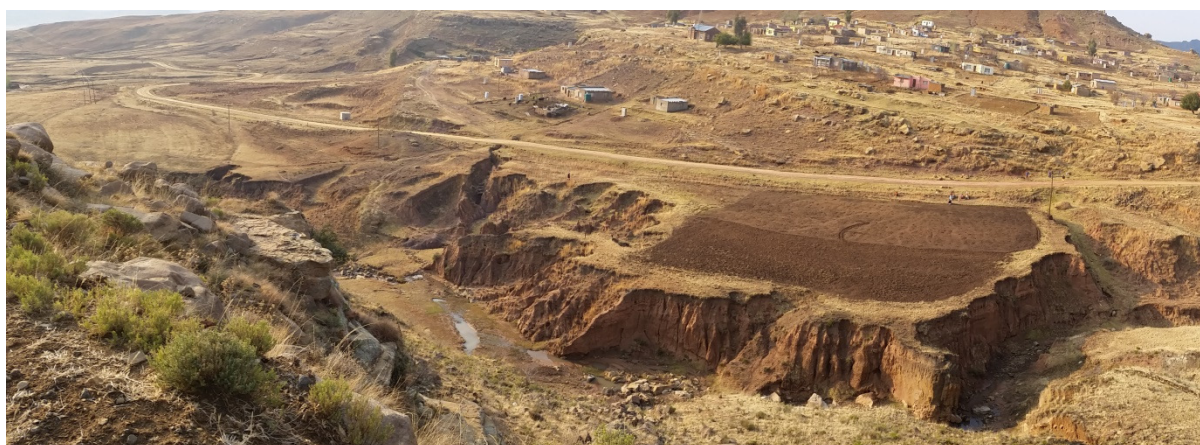
**Figure 4.1** An example of extensive erosion in the Upper Orange catchment
