APPENDIX E:
GEOMORPHOLOGY

Compiled by Mark Rountree, Fluvius Environmental Consultants

This report describes the specialist data analysis for the geomorphological component of the Orange River Environmental Flow Assessment study undertaken in 2010. The report includes the EcoClassification (“health”) assessments of the EFR sites, and the analysis undertaken to identify significant flows for channel and habitat maintenance.

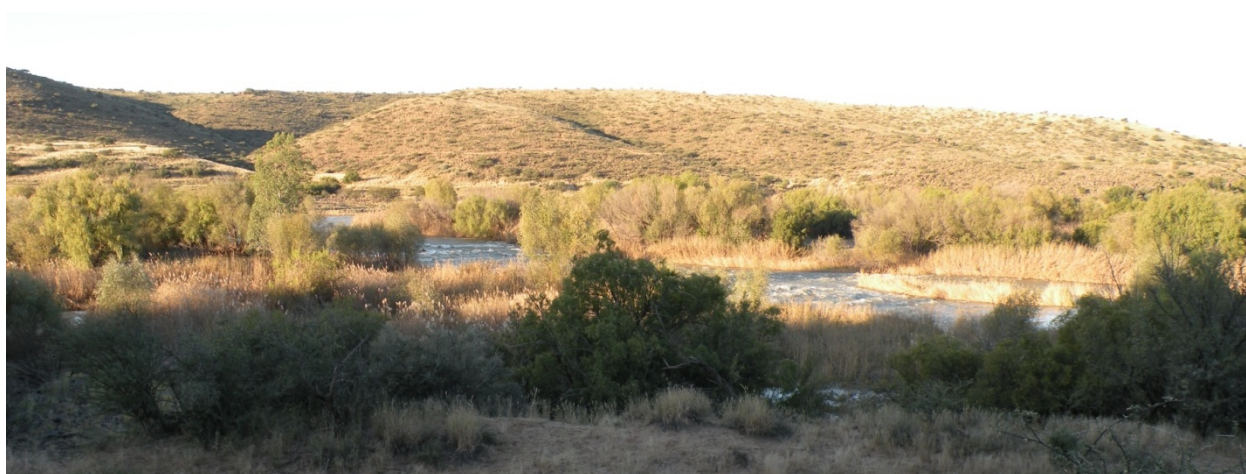
Figure E2 The banks and mid-channel bars at EFR O1 are well-vegetated

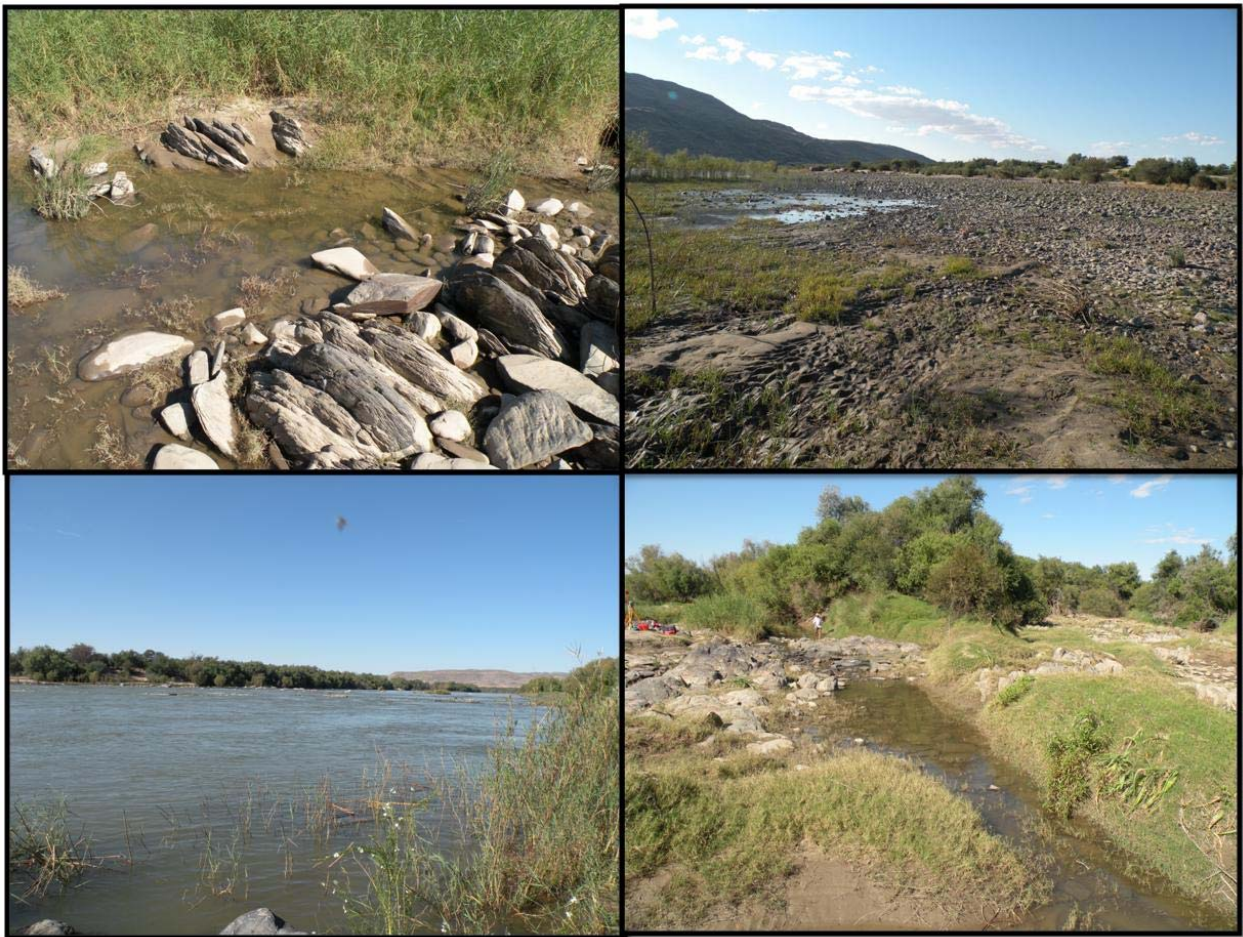
Figure E5 There is a high degree of physical habitat diversity associated with the numerous distributary channels at this site

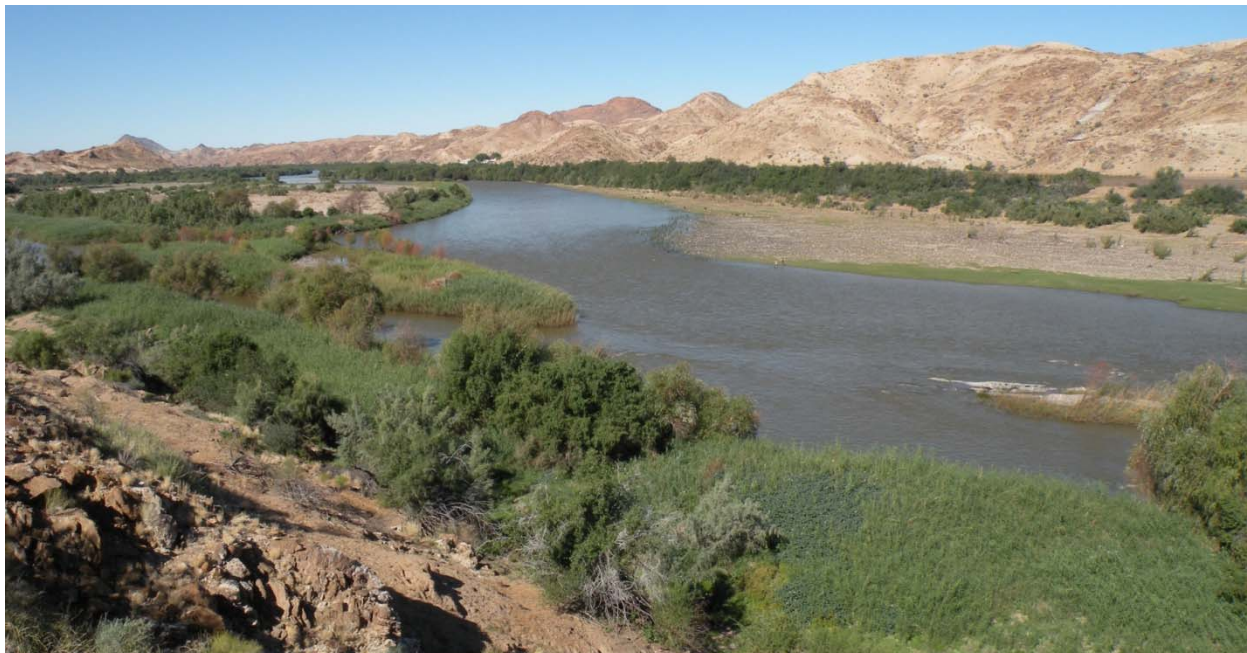
Figure E6 Large cobble bars and small fines deposits are present at EFR O3

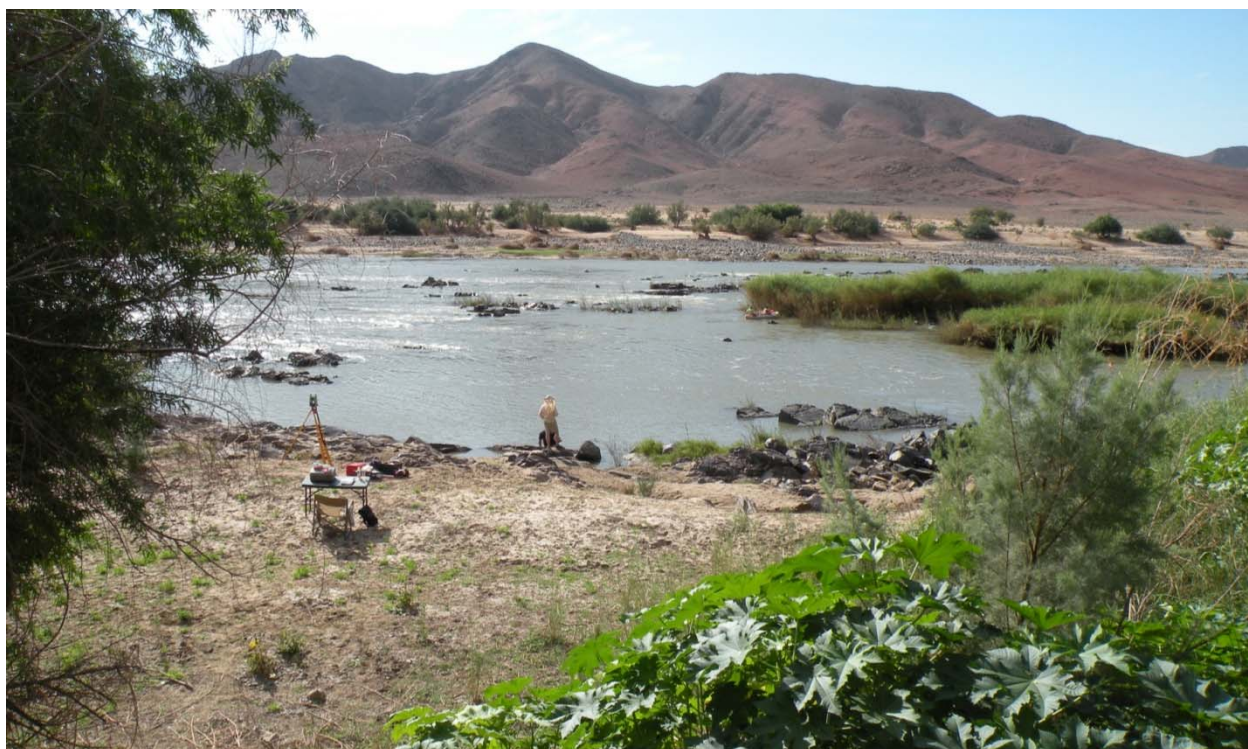
Figure E8 At EFR O4, there is a mix of cobbles, gravels and fine sediment deposits within the bedrock-controlled reach

The historical aerial photographic record indicates that small (bedrock core) bars within this pool rapid/riffle reach are, since the 1980's, becoming slightly more extensive and stable (increasingly vegetated). These may be responding to the very reduced low flows and near absence of moderate and large floods as occur at EFR O2 and O3. The reduced floods and baseflows (MAR is about one third of the virgin flow volumes) decrease the ability of the river to flush out sediment, whilst the surrounding tributaries are adding increasing volumes of sediment to the main channel.

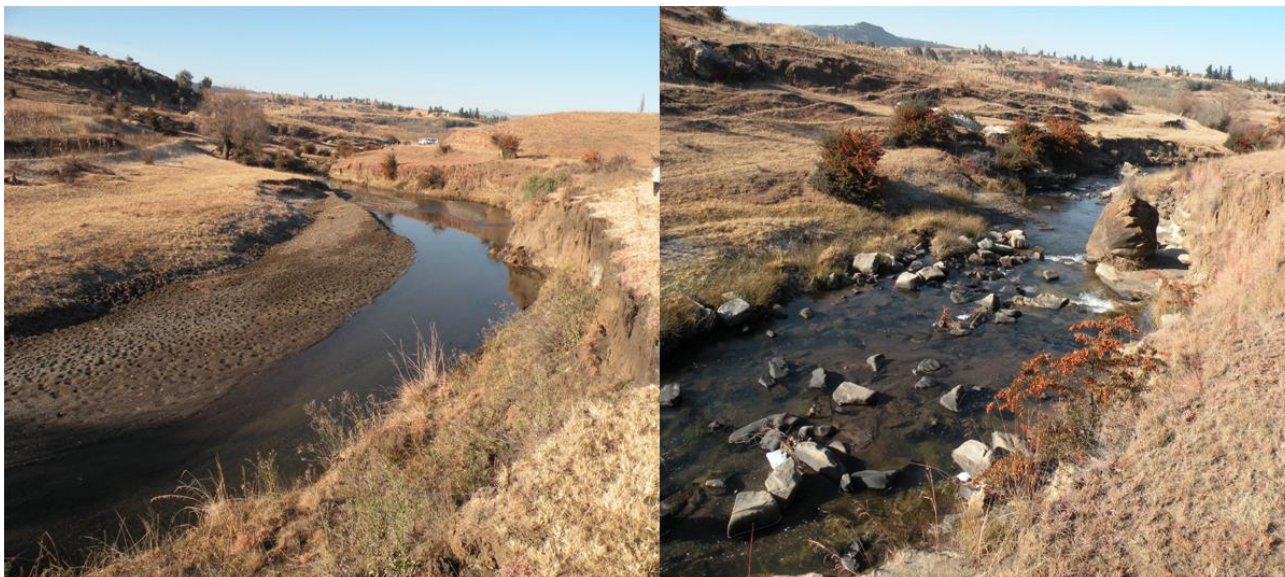
Figure E10 The increased fine sediments in the channel have converted large sections of the reach to a sandbed channel as the sands smother the underlying gravels and cobbles

The smothering of gravels and cobbles has converted extensive sections of the reach to a sandbed channel (Figure E10). The historical aerial photographic record (shown below) record a progressive loss of large woody vegetation (trees) along the banks of the main river in this reach. The removal of trees may be the result of bank erosion, heavy grazing pressures and firewood useage. The loss of woody vegetation may have further increased the bank destabilisation evident at the site, in turn further destabilised by livestock - grazing pressure is high.

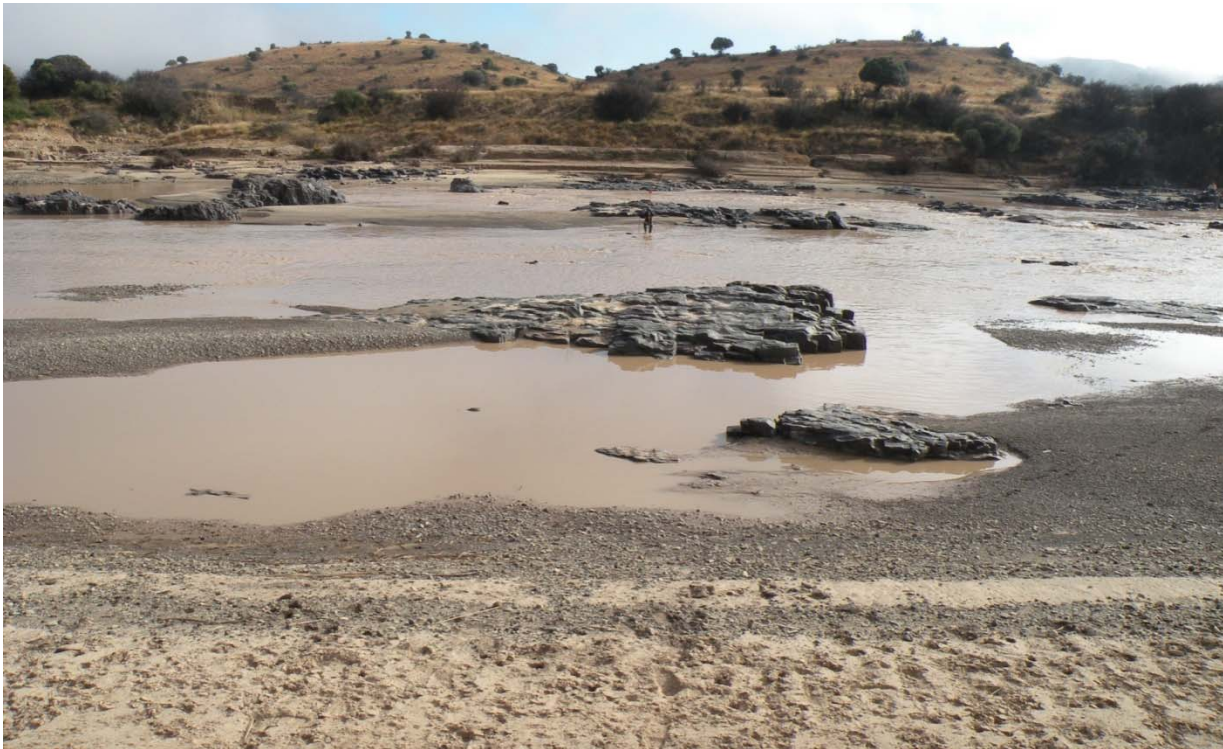
Figure E11 The bedrock riffle at the site is expected to be smothered by fines during very high flood flows due to backup impacts; but this feature is re-exposed during the receding limb of the floods when the backup effect is removed and velocities increase, enabling scour.

Given the increased sediment load from the catchment; the backup effects at the site during very large floods which promotes enhanced deposition; and the annual bottom releases from the upstream Welbedacht Dam (release of sediment slug during low flow periods to scour the dam), it is expected that this site has a much higher fines component, and more stable sediment deposits, than would have occurred naturally. In addition, the expected reduced velocities during very high floods may now be too low to scour the bed and activate the gravels.

The same aerial photographs do however show that the gross morphology of the low flow channels is relatively stable, and this is because at low and moderate flows the backup impacts are not in place, so erosion and scour of these low flow channels still occur despite the episodic smothering during high floods.

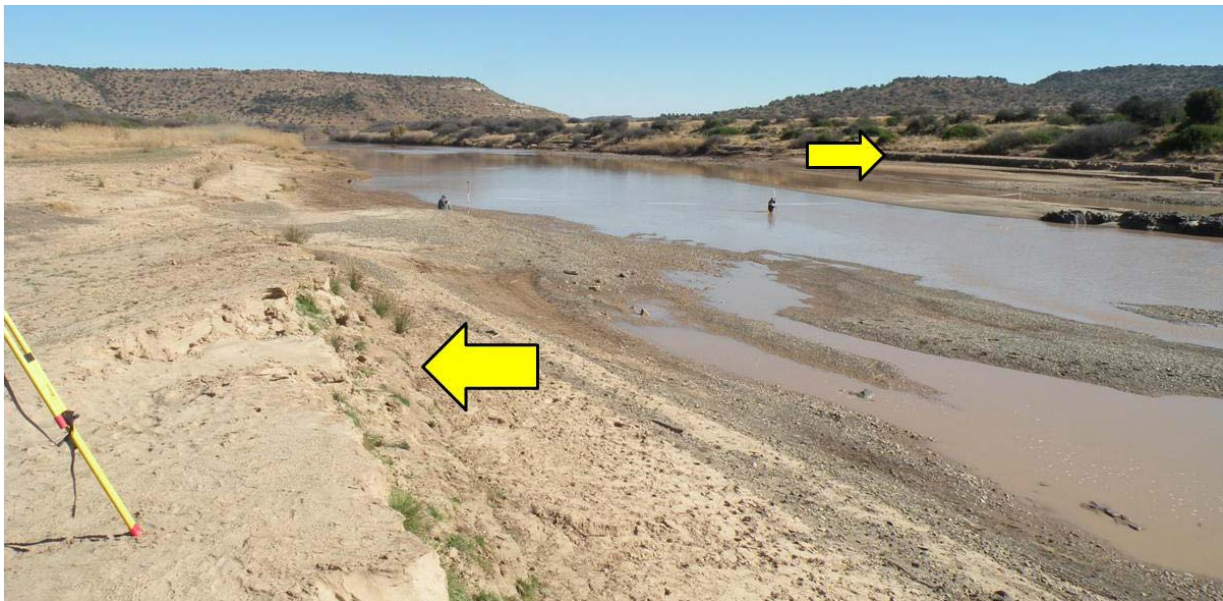
Figure E12 Thick sand/silt drapes deposited along both banks during high flood flows

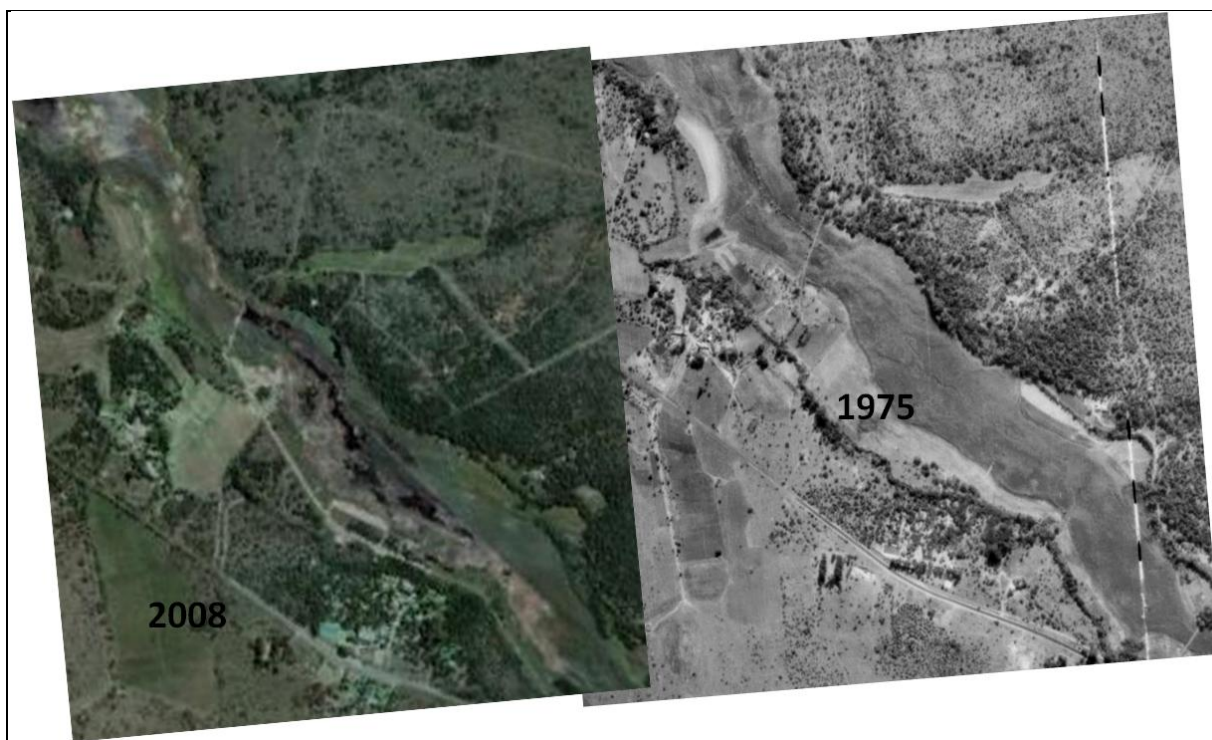
Figure E13 The road crossing has created an impoundment upstream. This has artificially increased the water level, and excavation in the wetland to create fishing and boating areas have created further disturbances in this area. Die off of the reeds has occurred between 1975 (right image) and 2008 (left image)

Small weirs, dams, road crossings and drains have also had a direct impact on the water distribution across the wetland surface. Since the 1970's, one or a combination of factors - raising of a road crossing, excavation of the peats for boating and fishing areas, and possible spraying of the reeds to kill them – has caused open water areas to develop in one section of the wetland (see Figure below). Downstream of this the reduced flows in the wetland, and trapping of flows behind the structures, has caused extensive desiccation and terrestrialisation of the wetland. Canalisation of sections of the wetland has also prevented water flowing diffusely across the valley bottom, further reducing the area of wetting.

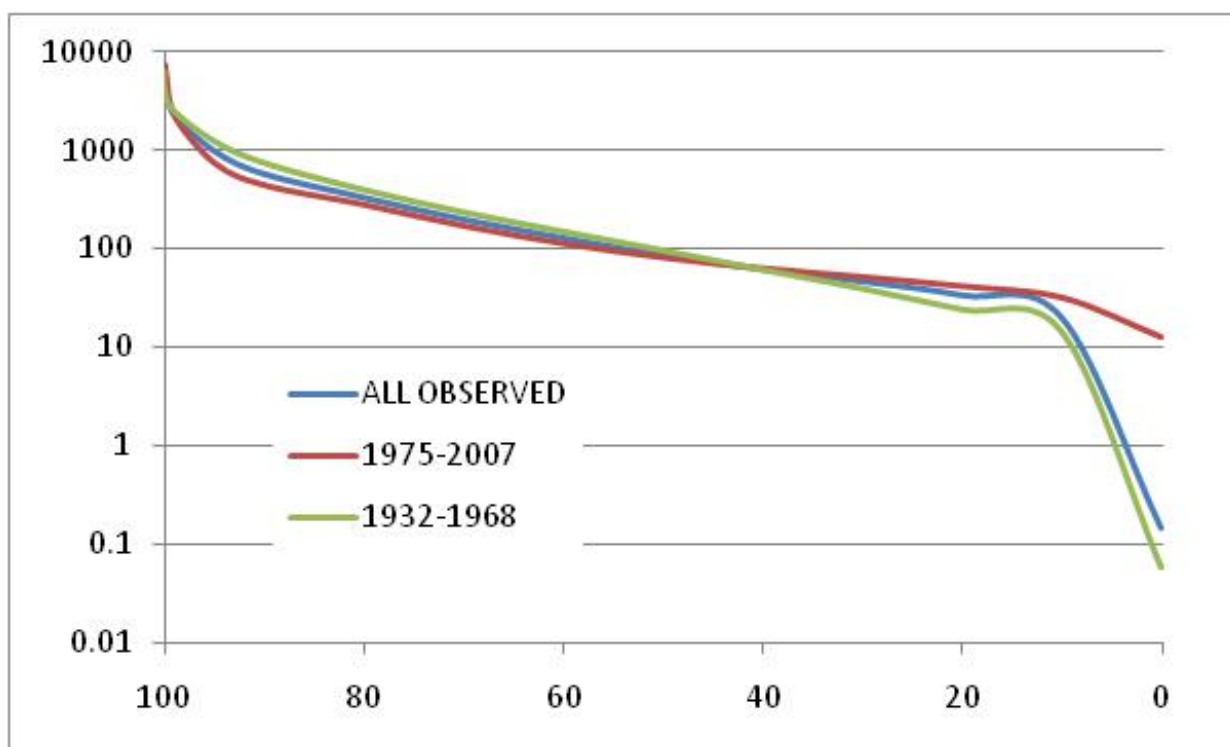
Figure E14 Flow duration curve (m^3/s on a log scale) of the daily observed data from 1932 to 2007

At EFR O2, a very long flow record enabled us to separate out a “near natural” record (from 1932 to 1968 – prior to the operation of any large dams) and a flow record relative of more recent flow conditions (essentially representing present-day conditions, indicated by the 1975 to 2007 period). The latter period displays elevated low flows but reduced high and flood flows relative to the 1932-1968 flow conditions (Figure E14).
