1 JBS09 (EWR 9: SUIKERBOS US (SUIKERBOSRAND RIVER))

1.1 SITE DESCRIPTION

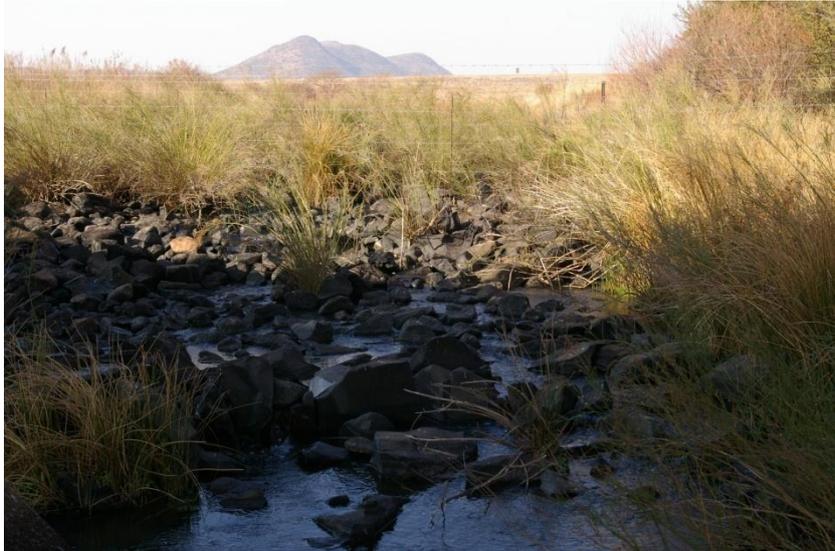
EWR 9, Suikerbos US, August 2008

EWR 9 is situated in the upper reaches of the Suikerbosrand River, and falls within MRU Suiker A delineated as from the origin of river to the confluence with Blesbokspruit River. The site is in a bedrock rapid, and although the reach is generally characterised by long pools, there are a number of such rapids in the reach. Some morphological cues present in the upstream pool area - upper terrace is paired on opposite the bank and the lower bench is annually flooded. Some channel manipulation from the construction of bridge downstream was observed and there is 40% exotic species coverage. Fish habitat, flow-depth categories and cover is well represented at site and macroinvertebrate habitat is moderate.
