1 JBS30 (EFR C6: LOWER CALEDON)

1.1 SITE DESCRIPTION

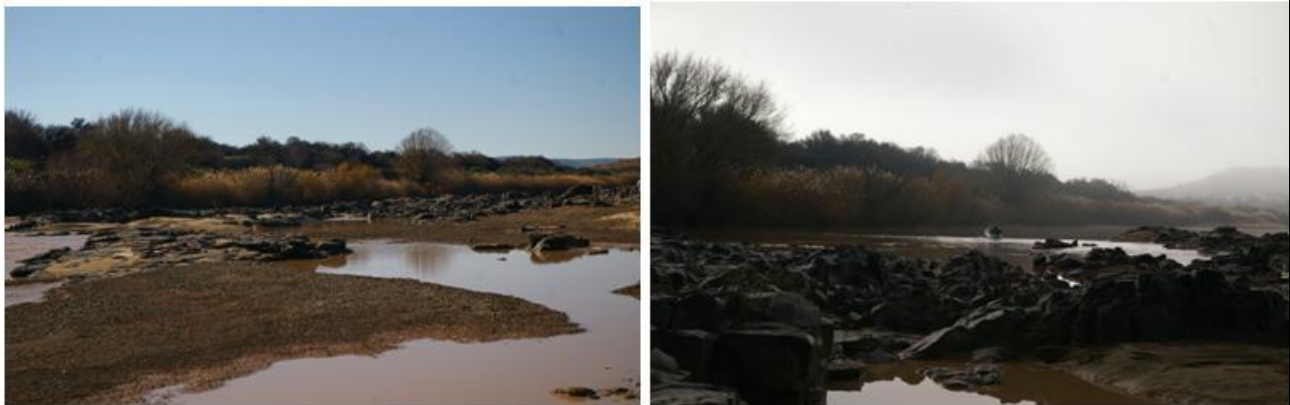
EFR C6, Upper Caledon River. Channel substrate includes boulder, bedrock, cobble and sand.

EFR C6 is situated in the lower reaches of the Caledon River in MRU D which is delineated from Tussen-Die-Riviere Game Reserve to backup of Gariep Dam. The site is 100 m wide at places and channel substrate includes boulder, bedrock, cobble and sand. The morphology of the site is generally representative of the reach, although such large bedrock riffles are not common. Although this is a bedrock rapid section, fines dominate the bed. Recent floods have deposited several metres of sediment along the banks. In the faster flowing sections of the bedrock rapid section of the channel there are some gravels and cobbles on the bed, but these are all embedded by fines. The condition of the site is probably slightly better than the reach due to location within nature reserve. Flow sensitive habitats for fish (FS and FD) are very well represented at the site and although habitat diversity is moderate. Turbidity is high with extensive sedimentation/siltation. Macroinvertebrate habitat is moderate with limited stones-in-current, marginal vegetation in and out of current and aquatic vegetation habitats.
