1 JBS32 (EFR O2: BOEGOEBERG (ORANGE RIVER))

1.1 SITE DESCRIPTION

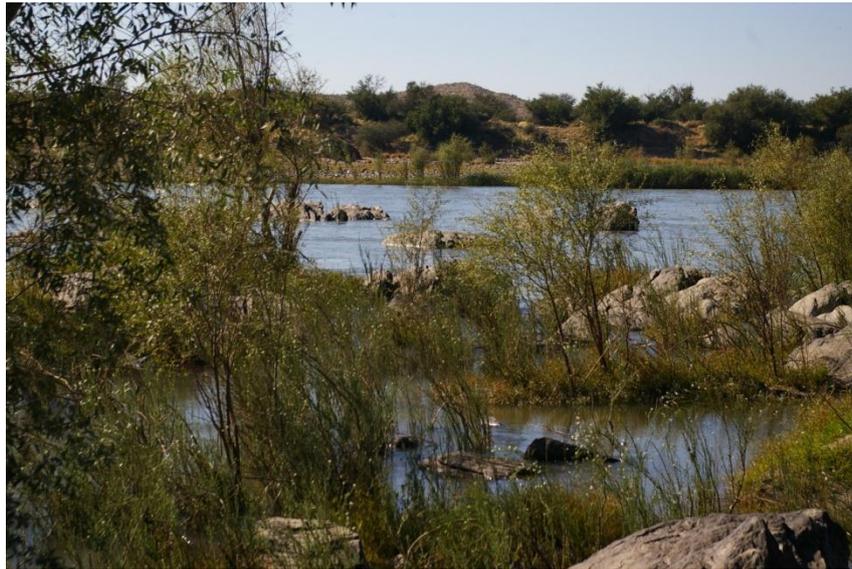
EFR O2, Lower Orange River. There is a high degree of physical habitat diversity associated with the numerous distributary channels at this site.

The site is situated below the Boegoeberg Dam and falls within MRU Orange D, RAU D1 which is delineated as the river reach below Boegoeberg Dam up to Augrabies Waterfall. The site falls within a reach that is less disturbed with no cultivation in the riparian zone and a canal is present on the left bank. This is a bedrock anastomosing reach, with well-vegetated bedrock core bars and islands between the distributary channels, and large bedrock riffle areas in the active channels. The macro-channel is approximately 400 – 500m wide with an average depth of 3 m. Flow sensitive habitats for fish (fast shallow (FS) and fast deep (FD)) are very well represented at site. High habitat diversity is present with various secondary canals.
