POST-MINING REHABILITATION, LAND USE AND POLLUTION

AT COLLIERIES IN SOUTH AFRICA

D. Limpitlaw¹, M. Aken², H. Lodewijks² and J. Viljoen³

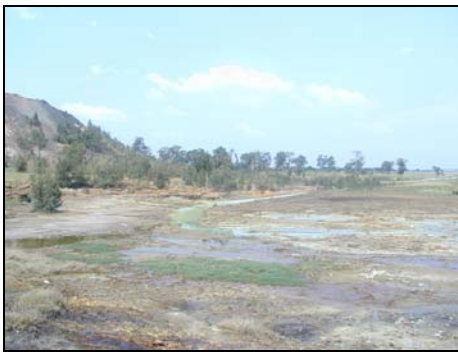
Figure 1. Water pollution arising from T&DB, an abandoned coal mine near Witbank.

At the old, abandoned Transvaal and Delagoa Bay colliery (T&DB), in Witbank, sink holes associated with *in situ* combustion of coal are evident. Bare patches are present around the sinkholes and gases are vented to atmosphere. The operation closed before rigorous closure practice was common and the former owners are no longer traceable. Rehabilitation of the site, now the responsibility of the state, may cost up to R100-million (Witcomb, pers. comm., 2001). The colliery began operating towards the end of the 19th century. Fires soon started, but were controlled while the mine was operating. Since closure in 1953, the fires have been out of control and in 1995, flames could be seen above ground. The 750 ha colliery site lies between the township of KwaGuqa and the industrial area of Ferrobank. Footpaths crisscross it, passing close to burning areas. Underground fires are not the only problem at the site. Acid water decants into the nearby Brugspruit. A R30-million treatment plant has been established treat this water but there are doubts about its effectiveness.

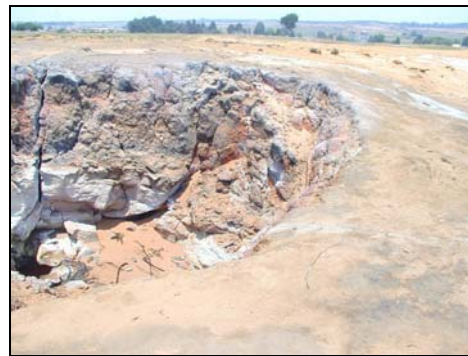
Figure 2. Surface collapse due to abandoned burning workings at T&DB.
